Access Compliance Report

Public Rights-of-Way

(Curb Ramps)

Intersection ID: 13086	Main Street: CENTRAL_AV	Cross Street: CLEMENT_AV	Location: SE
ADA ID: CE09DEBF232E	Ramp Type: Combination1	Initial Pass/Fail: Fail	Overall Compliance: No
			Severity Score: 13.75

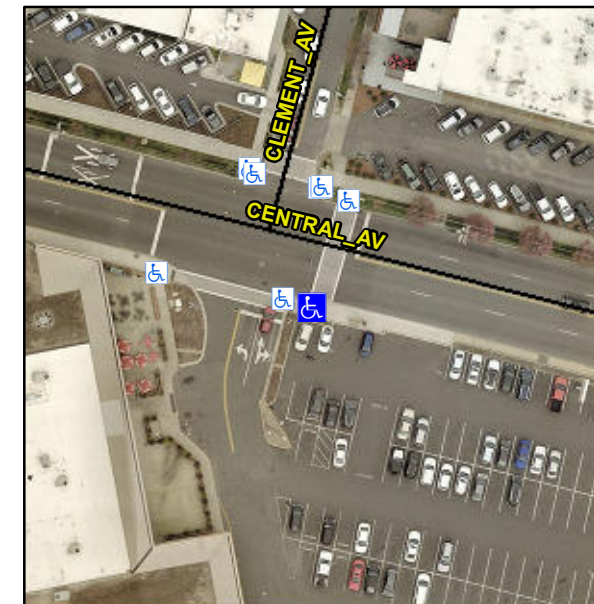
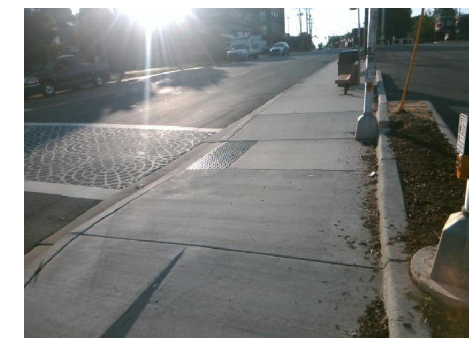
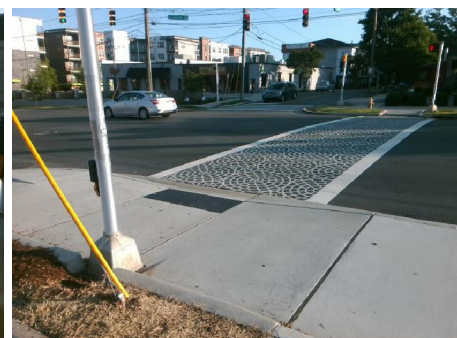
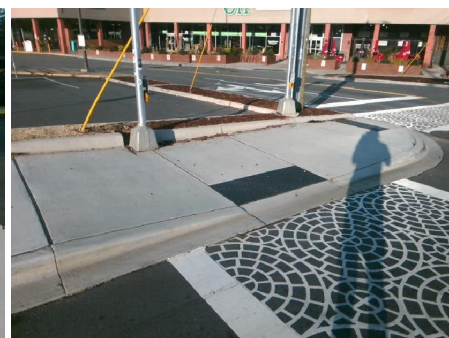
RT RP < 5%

Not Found, R304.5.3, R304.3.2

Compliance	Description	Data	Compliance	Description	Data
N/A	Ramp Length LT (in)	71.0	N/A	Ramp Length RT (in)	78.0
Yes	Ramp Width LT (in)	87.0	Yes	Ramp Width RT (in)	99.0
No	Ramp Slope LT (%)	9.4	Yes	Ramp Slope RT (%)	1.3
Yes	Ramp XSlope LT (%)	1.1	Yes	Ramp XSlope RT (%)	0.1
N/A	Ramp Length (in)	24.0	Yes	Ramp Slope (%)	3.2
Yes	Ramp Width (in)	60.0	No	Ramp XSlope (%)	2.8
N/A	Flare Type LT	N/A	N/A	Flare Type RT	N/A
N/A	Flare Slope LT (%)	N/A	N/A	Flare Slope RT (%)	N/A
N/A	Flare Traversable LT?	N/A	N/A	Flare Traversable RT?	N/A
N/A	Landing Length (in)	N/A	N/A	DWS Provided?	N/A
N/A	Landing Width (in)	N/A	N/A	DWS Contrast?	N/A
N/A	Landing Slope (%)	N/A	N/A	DWS Length (in)	N/A
N/A	Landing X Slope (%)	N/A	N/A	DWS Full Width?	N/A
N/A	Landing Curb? (Y/N)	N/A	N/A	DWS Offset (in)	N/A
N/A	Shared Landing?	N/A			
N/A	Gutter Ponding?	N/A	N/A	Gutter Slope (%)	N/A
N/A	Gutter Lip Ht (in)	N/A	N/A	Gutter X Slope (%)	N/A
N/A	Painted X Walk1?	Yes	N/A	Painted X Walk2?	N/A

X Walk 1 Direction	To N		X Walk 2 Direction	N/A
	X Walk 1 Width (in)	121.0		X Walk 2 Width (in)	N/A
	X Walk 1 Slope (%)	3.1		X Walk 2 Slope (%)	N/A
	X Walk 1 X Slope (%)	2.1		X Walk 2 X Slope (%)	N/A
N/A	Ramp inside XWalk1?	Yes	N/A	Ramp inside XWalk2?	N/A
	Road Slope (%)	N/A		Clear Space?	N/A
	Road X Slope (%)	N/A	N/A	Clear Space to XWalk (in)	N/A
			N/A	Any Obstruction?	N/A
				Obstruction Type	N/A
			N/A	Storm Grate/Utility Hazard?	N/A
				Storm Grate/Utility Type	N/A
			Yes	Surface Condition? (G/P)	Good
				Curb Slope (%)	7.2

Remove & Replace Entire Ramp.
