Access Compliance Report

Public Rights-of-Way (Curb Ramps)

Intersection ID: N/A	Main Street: BRECKFIELD_CT	Cross Street: KIRKWYND_COMMONS_DR	Location: S
ADA ID: CE09FD750D71	Ramp Type: Perp	Initial Pass/Fail: Fail	Overall Compliance: No
		Severity Score: 12.5

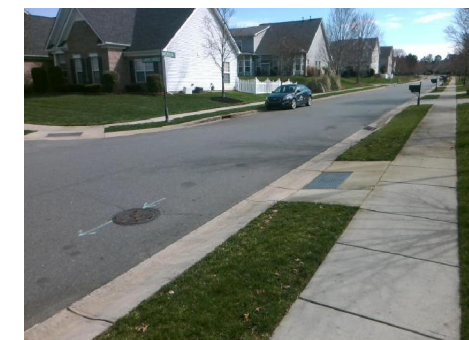
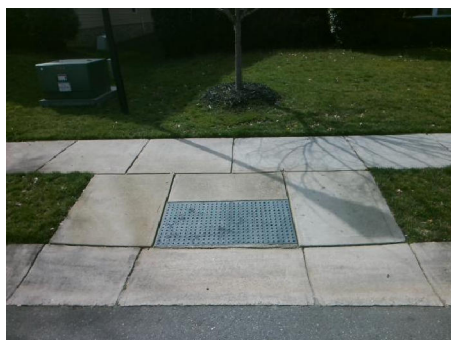
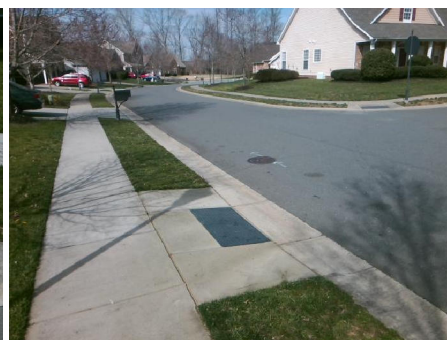
R304.2.2

Compliance	Description	Data	Compliance	Description	Data
N/A	Ramp Length (in)	48.0	No	Ramp Slope (%)	11.2
Yes	Ramp Width (in)	48.0	Yes	Ramp XSlope (%)	1.3
N/A	Flare Type LT	N/A	N/A	Flare Type RT	N/A
N/A	Flare Slope LT (%)	N/A	N/A	Flare Slope RT (%)	N/A
N/A	Flare Traversable LT?	N/A	N/A	Flare Traversable RT?	N/A
N/A	Landing Length (in)	N/A	N/A	DWS Provided?	N/A
N/A	Landing Width (in)	N/A	N/A	DWS Contrast?	N/A
N/A	Landing Slope (%)	N/A	N/A	DWS Length (in)	N/A
N/A	Landing X Slope (%)	N/A	N/A	DWS Full Width?	N/A
N/A	Landing Curb? (Y/N)	N/A	N/A	DWS Offset (in)	N/A
N/A	Shared Landing?	N/A			
N/A	Gutter Ponding?	N/A	N/A	Gutter Slope (%)	N/A
N/A	Gutter Lip Ht (in)	N/A	N/A	Gutter X Slope (%)	N/A
N/A	Painted X Walk1?	No	N/A	Painted X Walk2?	N/A
	X Walk 1 Direction	To NE		X Walk 2 Direction	N/A
N/A	X Walk 1 Width (in)	N/A	N/A	X Walk 2 Width (in)	N/A
	X Walk 1 Slope (%)	3.8		X Walk 2 Slope (%)	N/A
	X Walk 1 X Slope (%)	2.1		X Walk 2 X Slope (%)	N/A

Possible Solutions:

Remove & Replace Entire Ramp.

\$ 1850.00
