Access Compliance Report

Public Rights-of-Way

(Curb Ramps)

| Intersection ID: 13389 | Main Street: ELIZABETH_AV | Cross Street: N_KINGS_DR | Location: E |

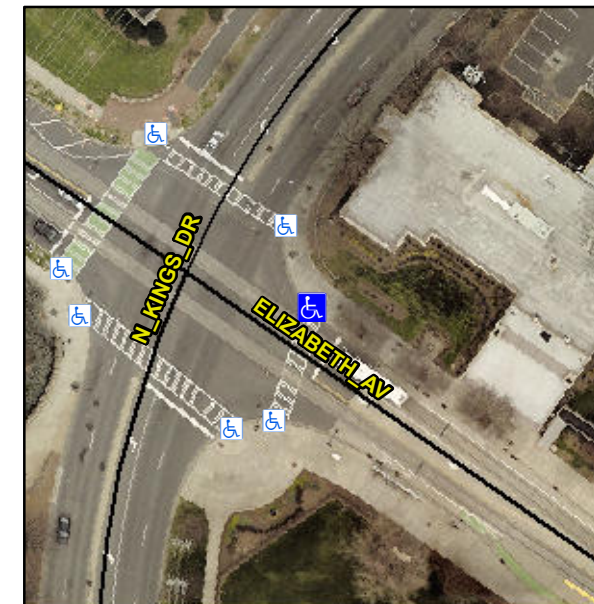
| ADA ID: CE0B979C6D31 | Ramp Type: Perp | Initial Pass/Fail: Fail | Overall Compliance: No |

Not Found, R304.2.2

| Compliance | Description | Data | Compliance | Description | Data |
|---|---|---|---|---|---|
| N/A | Ramp Length (in) | 72.0 | No | Ramp Slope (%) | 8.4 |

Remove & Replace Entire Ramp.

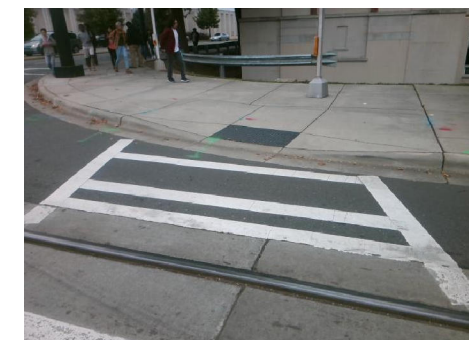
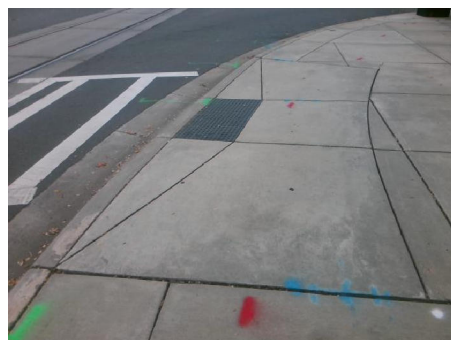
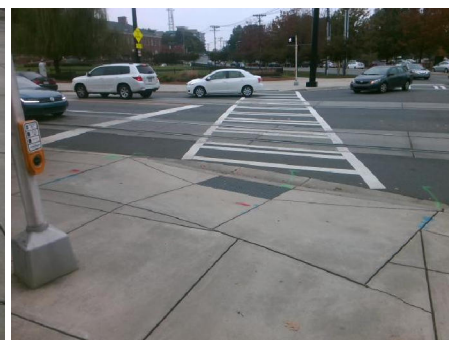
| Compliance | Description | Data | Compliance | Description | Data |
|---|---|---|---|---|---|
| | | Yes | | Surface Condition? (G/P) | Good |
