Access Compliance Report

Public Rights-of-Way

(Curb Ramps)

Intersection ID: 2932	Main Street: GREEN_HEDGE_AV	Cross Street: WINTER_PINE_LN	Location: NE
ADA ID: CE25E418DCED	Ramp Type: Perp	Initial Pass/Fail: Fail	Overall Compliance: No
Severity Score: 22.5			
Codes/Mitigation Info/Possible Solution		Field Measurements/Component Compliance

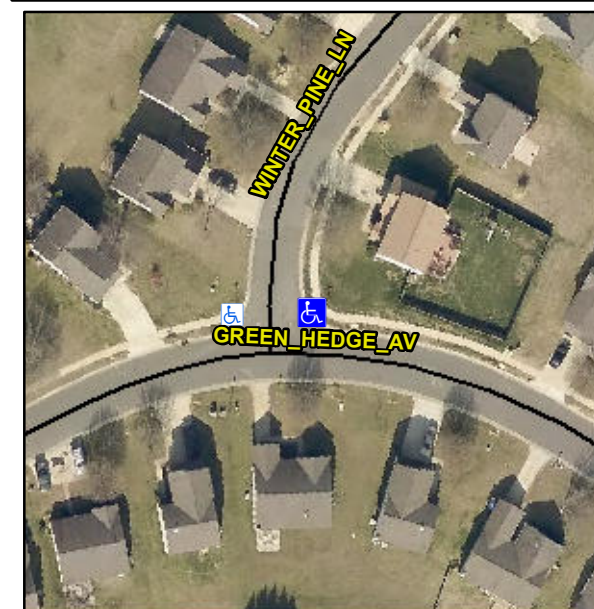
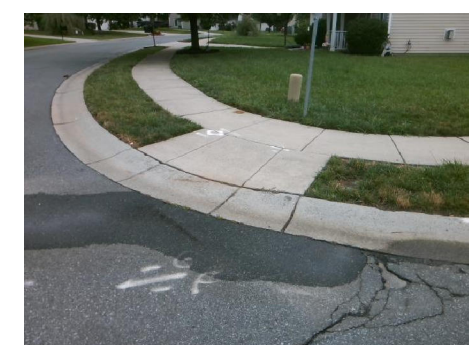
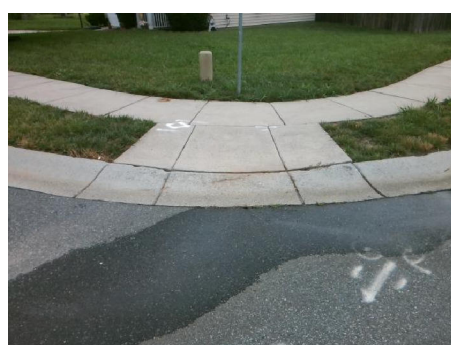
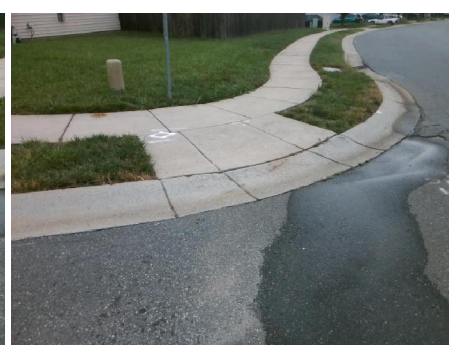
Compliance	Description	Data	Compliance	Description	Data
N/A	Ramp Length (in)	48.0	No	Ramp Slope (%)	9.8
No	Ramp Width (in)	38.0	No	Ramp XSlope (%)	3.5
N/A	Flare Type LT	N/A	N/A	Flare Type RT	N/A
N/A	Flare Slope LT (%)	N/A	N/A	Flare Slope RT (%)	N/A
N/A	Flare Traversable LT?	N/A	N/A	Flare Traversable RT?	N/A
N/A	Landing Length (in)	N/A	N/A	DWS Provided?	N/A
N/A	Landing Width (in)	N/A	N/A	DWS Contrast?	N/A
N/A	Landing Slope (%)	N/A	N/A	DWS Length (in)	N/A
N/A	Landing X Slope (%)	N/A	N/A	DWS Full Width?	N/A
N/A	Landing Curb? (Y/N)	N/A	N/A	DWS Offset (in)	N/A
N/A	Shared Landing?	N/A			
N/A	Gutter Ponding?	N/A	N/A	Gutter Slope (%)	N/A
N/A	Gutter Lip Ht (in)	N/A	N/A	Gutter X Slope (%)	N/A
N/A	Painted X Walk1?	No	N/A	Painted X Walk2?	N/A
	X Walk 1 Direction	To W		X Walk 2 Direction	N/A
N/A	X Walk 1 Width (in)	N/A	N/A	X Walk 2 Width (in)	N/A
	X Walk 1 Slope (%)	0.8		X Walk 2 Slope (%)	N/A
	X Walk 1 X Slope (%)	2.0		X Walk 2 X Slope (%)	N/A

N/A	Ramp inside XWalk1?	N/A	N/A	Ramp inside XWalk2?	N/A
	Road Slope (%)	N/A	N/A	Clear Space?	N/A
	Road X Slope (%)	N/A	N/A	Clear Space to XWalk (in)	N/A
N/A	Any Obstructions?	N/A	N/A	Storm Grate/Utility Hazard?	N/A
	Obstruction Type			Storm Grate/Utility Type	
		N/A			N/A
			Yes	Surface Condition? (G/P)	Good

Possible Solutions:

Remove & Replace Entire Ramp.

R304.5.1, R304.2.2, R304.5.3
