Access Compliance Report

Public Rights-of-Way

(Curb Ramps)

Intersection ID: 8125	Main Street: CROSSRIDGE_RD	Cross Street: EAGLE_PEAK_DR	Location:	E
ADA ID: CE3DED2596BE	Ramp Type: Perp	Initial Pass/Fail: Fail	Overall Compliance: No	Severity Score: 25

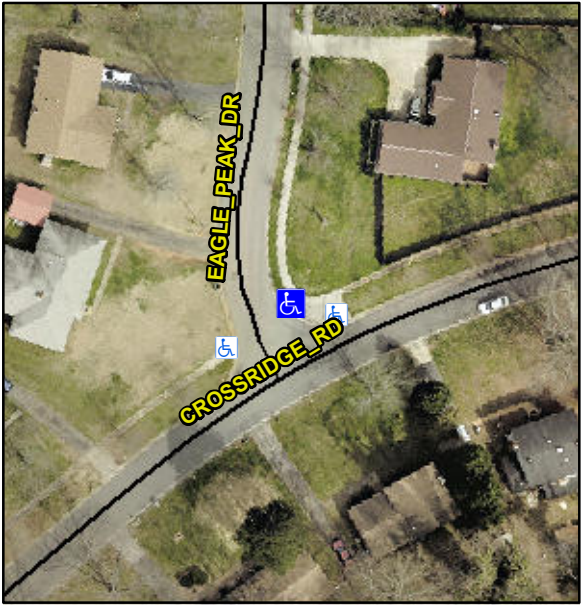
Possible Solutions:		Compliance	Description	Data
	Remove & Replace Entire Ramp.		N/A	Ramp Length (in)	49.0
			Yes	Ramp Width (in)	48.0
			N/A	Flare Type LT	N/A
			N/A	Flare Slope LT (%)	N/A
			N/A	Flare Traversable LT?	N/A
			N/A	Landing Length (in)	N/A
			N/A	Landing Width (in)	N/A
			N/A	Landing Slope (%)	N/A
			N/A	Landing X Slope (%)	N/A
<p>Surveyor Notes:</p> <p>N/A</p> <p>PROW/ADA:</p> <p>Not Found, R304.2.2, R304.5.3</p>			N/A	Flare Type RT	N/A
			N/A	Flare Slope RT (%)	N/A
			N/A	Flare Traversable RT?	N/A
			N/A	DWS Provided?	N/A
			N/A	DWS Contrast?	N/A
			N/A	DWS Length (in)	N/A
			N/A	DWS Full Width?	N/A
			N/A	DWS Offset (in)	N/A
			N/A	Shared Landing?	N/A
			N/A	Gutter Ponding?	N/A
			N/A	Gutter Lip Ht (in)	N/A
			N/A	Painted X Walk1?	No
				X Walk 1 Direction	To W
			N/A	X Walk 1 Width (in)	N/A
				X Walk 1 Slope (%)	4.0

X Walk 1 X Slope (%)	4.7
			N/A	Ramp inside XWalk1?	N/A
				Road Slope (%)	N/A
				Road X Slope (%)	N/A
			N/A	Any Obstructions?	N/A
				Obstruction Type	
Total Cost:		\$ 1850.00			
			N/A		N/A
			Yes	Surface Condition? (G/P)	Good
