Access Compliance Report

Public Rights-of-Way

(Curb Ramps)

Intersection ID: 10203	Main Street: BARRINGTON_DR	Cross Street: ROSECRAN_DR	Location: NW
ADA ID: CE3E66F6BA2F	Ramp Type: Perp	Initial Pass/Fail: Fail	Overall Compliance: No
		Severity Score: 25

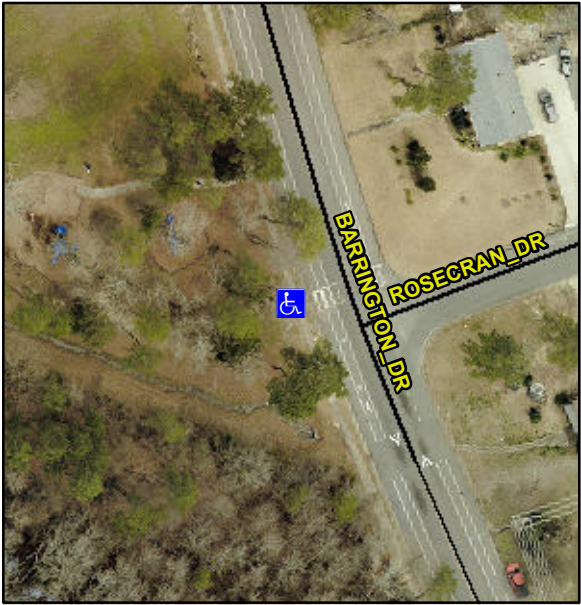
Possible Solutions:		Compliance	Description	Data
	Remove & Replace Entire Ramp.		No	Ramp Length (in)	31.0
	Restripe Crosswalk.		Yes	Ramp Width (in)	132.5
			N/A	Flare Type LT	N/A
			N/A	Flare Slope LT (%)	N/A
			N/A	Flare Traversable LT?	N/A
			N/A	Landing Length (in)	N/A
			N/A	Landing Width (in)	N/A
			N/A	Landing Slope (%)	N/A
			N/A	Landing X Slope (%)	N/A
<p>Surveyor Notes:</p> <p>N/A</p> <p>PROW/ADA:</p> <p>Not Found, R304.2.2</p>			N/A	Flare Type RT	N/A
			N/A	Flare Slope RT (%)	N/A
			N/A	Flare Traversable RT?	N/A
			N/A	DWS Provided?	N/A
			N/A	DWS Contrast?	N/A
			N/A	DWS Length (in)	N/A
			N/A	DWS Full Width?	N/A
			N/A	DWS Offset (in)	N/A
			N/A	Shared Landing?	N/A
			N/A	Gutter Ponding?	N/A
			N/A	Gutter Lip Ht (in)	1.5
			N/A	Painted X Walk1?	Yes
				X Walk 1 Direction	To E
			N/A	X Walk 1 Width (in)	120.0
				X Walk 1 Slope (%)	5.5

X Walk 1 X Slope (%)	2.6
			N/A	Ramp inside XWalk1?	No
			N/A	Road Slope (%)	2.6
			N/A	Road X Slope (%)	5.5
			N/A	Any Obstructions?	N/A
				Obstruction Type	
			N/A		
			N/A		
			N/A		
			N/A		
			N/A		
			N/A		
			N/A		
			N/A		
			N/A		
Total Cost:		\$ 2050.00			
			N/A		N/A
			Yes	Surface Condition? (G/P)	Good
