Access Compliance Report Public Rights-of-Way (Curb Ramps)

Intersection ID: 28643	Intersection ID: 28643 Main Street: BRYNFIELD_DR			Cross Street: PROVIDENCE_RD_WEST				Location:	S
ADA ID: CE40C293EFE	EFED Ramp Type: PerpDiag			Initial Pass/Fail: Fail Overall Compliance				o Severity Score:	12.5
Codes/Mitigation Info/Possible Solution				Field Measurements/Component Compliance					
Same Carlos and		Possible Solutions:		Compliance Description			Data Compliance Description		
and the the		Remove & Replace Curb Ramp W Two New Directional Ramps or Equivalent.	With	N/A	Ramp Length (in)	59.0	Yes	Ramp Slope (%)	6.9
Part of the second				Yes	Ramp Width (in)	70.0	No	Ramp XSlope (%)	5.3
				N/A	Flare Type LT	N/A	N/A	Flare Type RT	N/A
	TUBE.			N/A	Flare Slope LT (%)	N/A	N/A	Flare Slope RT (%)	N/A
a when the	Ser Contraction	1		N/A	Flare Traversable LT?	N/A	N/A	Flare Traversable RT?	N/A
AND THE REAL				N/A	Landing Length (in)	N/A	N/A	DWS Provided?	N/A
DE DUU		Surveyor Notes:		N/A	Landing Width (in)	N/A	N/A	DWS Contrast?	N/A

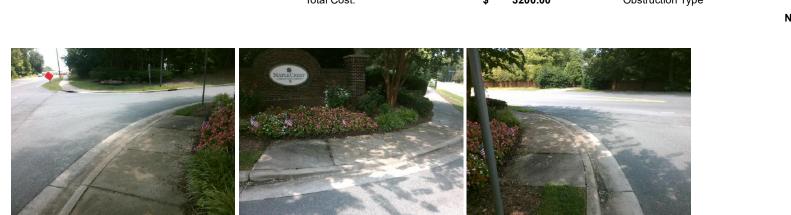
L Contraction	N/A		N/A	Landing Slope (%)	N/A	N/A	DWS Length (in)	N/A
	N/A		N/A	Landing X Slope (%)	N/A	N/A	DWS Full Width?	N/A	
PROW/ADA: Not Found, R304.5.3				N/A	Landing Curb? (Y/N)	N/A	N/A	DWS Offset (in)	N/A
				N/A	Shared Landing?	N/A		Dwe onset (iii)	10/0
				N/A	Gutter Ponding?	N/A	N/A	Gutter Slope (%)	N/A
				N/A	0	N/A		,	N/A N/A
					Gutter Lip Ht (in)			Gutter X Slope (%)	
				N/A	Painted X Walk1?	No	N/A	Painted X Walk2?	No
					X Walk 1 Direction	To NE		X Walk 2 Direction	To N
				N/A	X Walk 1 Width (in)	N/A	N/A	X Walk 2 Width (in)	N/A
Street 1 Name	BRYNFIELD DR				X Walk 1 Slope (%)	2.1		X Walk 2 Slope (%)	2.6
Stop Condition-Street 2	StopSign				X Walk 1 X Slope (%)	3.1		X Walk 2 X Slope (%)	2.7
Street 2 Name	PROVIDENCE RD WEST			N/A	Ramp inside XWalk1?	N/A		Ramp inside XWalk2?	N/A
Stop Condition-Street 1	None				Road Slope (%)	4.7	N/A	Clear Space?	N/A
					Road X Slope (%)	1.4	N/A	Clear Space to XWalk (in)	N/A

N/A	Any Obstructions?	N/A	N/A	Storm Grate/Utility Hazard?	N/A
		Total Cost: \$	3200.00		Obstruction Type			Storm Grate/Utility Type	
						N/A			N/A
