# Access Compliance Report

## Public Rights-of-Way

Intersection ID: 15542	Main Street: CLANTON_RD	Cross Street: N_I-77_TO_CLANTON_RD_RA	Location: SW
ADA ID: CE6CA46CAB35	Ramp Type: Perp	Initial Pass/Fail: Fail	Overall Compliance: No
			Severity Score: 12.5

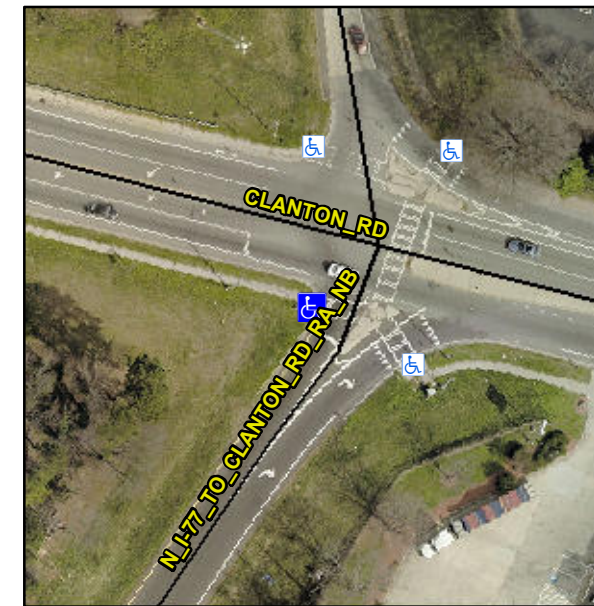
**R304.2.2**

Compliance	Description	Data	Compliance	Description	Data
N/A	Ramp Length (in)	80.0	No	Ramp Slope (%)	10.1
Yes	Ramp Width (in)	48.0	Yes	Ramp XSlope (%)	1.0
N/A	Flare Type LT	N/A	N/A	Flare Type RT	N/A
N/A	Flare Slope LT (%)	N/A	N/A	Flare Slope RT (%)	N/A
N/A	Flare Traversable LT?	N/A	N/A	Flare Traversable RT?	N/A
N/A	Landing Length (in)	N/A	N/A	DWS Provided?	N/A
N/A	Landing Width (in)	N/A	N/A	DWS Contrast?	N/A
N/A	Landing Slope (%)	N/A	N/A	DWS Length (in)	N/A
N/A	Landing X Slope (%)	N/A	N/A	DWS Full Width?	N/A
N/A	Landing Curb? (Y/N)	N/A	N/A	DWS Offset (in)	N/A
N/A	Shared Landing?	N/A			
N/A	Gutter Ponding?	N/A	N/A	Gutter Slope (%)	N/A
N/A	Gutter Lip Ht (in)	N/A	N/A	Gutter X Slope (%)	N/A
N/A	Painted X Walk1?	Yes	N/A	Painted X Walk2?	N/A
	X Walk 1 Direction	To E		X Walk 2 Direction	N/A
N/A	X Walk 1 Width (in)	111.0	N/A	X Walk 2 Width (in)	N/A
	X Walk 1 Slope (%)	2.2		X Walk 2 Slope (%)	N/A
	X Walk 1 X Slope (%)	1.9		X Walk 2 X Slope (%)	N/A

**Remove & Replace Entire Ramp.**

Total Cost: \$ 1850.00
