Access Compliance Report

Public Rights-of-Way

(Curb Ramps)

Intersection ID: 15360	Main Street: NEW_BERN_ST	Cross Street: RAIL_CROSSING_LN	Location: SE
ADA ID: CE727C2F1CCE	Ramp Type: Perp	Initial Pass/Fail: Fail	Overall Compliance: No
Severity Score: 12.5			
Codes/Mitigation Info/Possible Solution		Field Measurements/Component Compliance

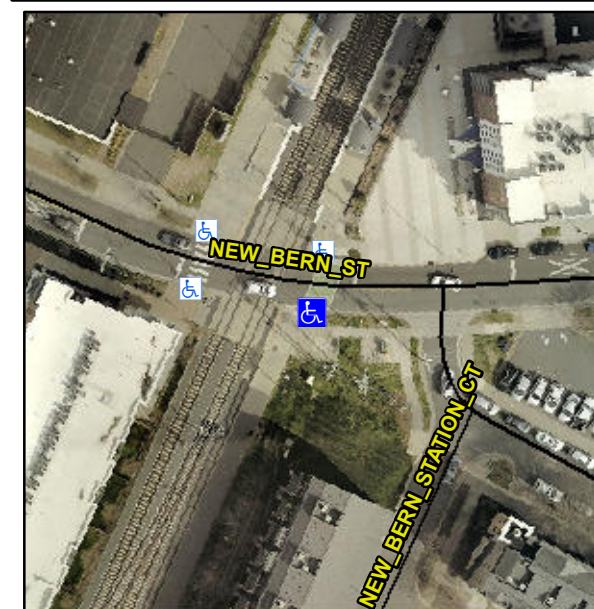
Not Found, R304.2.2

Compliance	Description	Data	Compliance	Description	Data
N/A	Ramp Length (in)	80.0	No	Ramp Slope (%)	9.1
Yes	Ramp Width (in)	136.0	Yes	Ramp XSlope (%)	0.4
N/A	Flare Type LT	N/A	N/A	Flare Type RT	N/A
N/A	Flare Slope LT (%)	N/A	N/A	Flare Slope RT (%)	N/A
N/A	Flare Traversable LT?	N/A	N/A	Flare Traversable RT?	N/A
N/A	Landing Length (in)	N/A	N/A	DWS Provided?	N/A
N/A	Landing Width (in)	N/A	N/A	DWS Contrast?	N/A
N/A	Landing Slope (%)	N/A	N/A	DWS Length (in)	N/A
N/A	Landing X Slope (%)	N/A	N/A	DWS Full Width?	N/A
N/A	Landing Curb? (Y/N)	N/A	N/A	DWS Offset (in)	N/A
N/A	Shared Landing?	N/A			
N/A	Gutter Ponding?	N/A	N/A	Gutter Slope (%)	N/A
N/A	Gutter Lip Ht (in)	N/A	N/A	Gutter X Slope (%)	N/A
N/A	Painted X Walk1?	Yes	N/A	Painted X Walk2?	N/A
	X Walk 1 Direction	To N		X Walk 2 Direction	N/A
N/A	X Walk 1 Width (in)	152.0	N/A	X Walk 2 Width (in)	N/A
	X Walk 1 Slope (%)	3.4		X Walk 2 Slope (%)	N/A
	X Walk 1 X Slope (%)	1.3		X Walk 2 X Slope (%)	N/A

N/A	Ramp inside XWalk1?	Yes	N/A	Ramp inside XWalk2?	N/A
	Road Slope (%)	N/A	N/A	Clear Space?	N/A
	Road X Slope (%)	N/A	N/A	Clear Space to XWalk (in)	N/A
N/A	Any Obstructions?	N/A	N/A	Storm Grate/Utility Hazard?	N/A
	Obstruction Type			Storm Grate/Utility Type	
		N/A			N/A
		Yes		Surface Condition? (G/P)	Good

Possible Solutions:

Remove & Replace Entire Ramp.

Total Cost: \$ 1850.00
