Access Compliance Report

Public Rights-of-Way

(Curb Ramps)

Intersection ID: 31215	Main Street: OLDEHURST_PL	Cross Street: WRAYHILL_DR	Location: NE
ADA ID: CE7411498102	Ramp Type: PerpDiag	Initial Pass/Fail: Fail	Overall Compliance: No
		Severity Score: 8.75

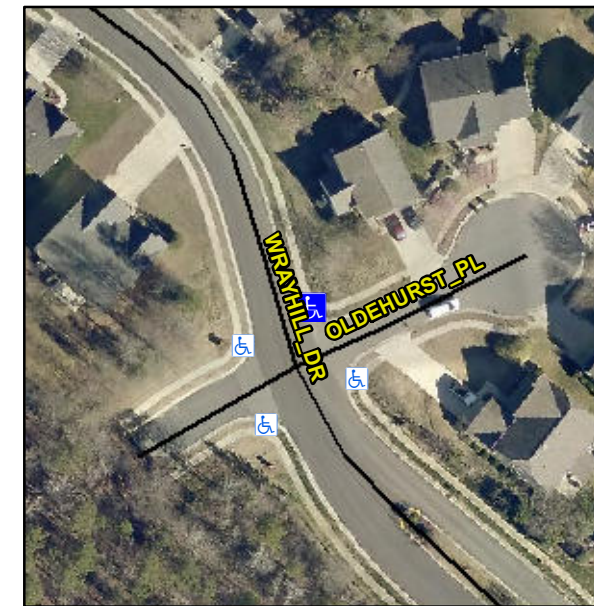
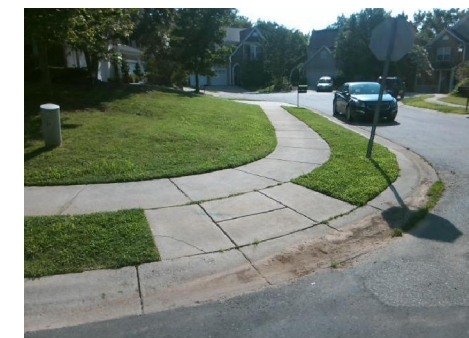
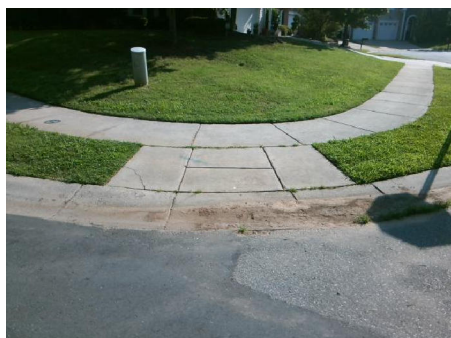
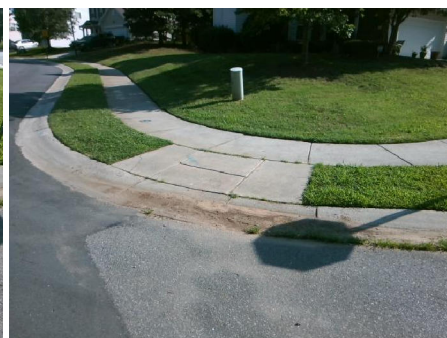
Compliance	Description	Data	Compliance	Description	Data
N/A	Ramp Length (in)	48.0	Yes	Ramp Slope (%)	8.0
No	Ramp Width (in)	36.0	Yes	Ramp XSlope (%)	1.7
N/A	Flare Type LT	N/A	N/A	Flare Type RT	N/A
N/A	Flare Slope LT (%)	N/A	N/A	Flare Slope RT (%)	N/A
N/A	Flare Traversable LT?	N/A	N/A	Flare Traversable RT?	N/A
N/A	Landing Length (in)	N/A	N/A	DWS Provided?	N/A
N/A	Landing Width (in)	N/A	N/A	DWS Contrast?	N/A
N/A	Landing Slope (%)	N/A	N/A	DWS Length (in)	N/A
N/A	Landing X Slope (%)	N/A	N/A	DWS Full Width?	N/A
N/A	Landing Curb? (Y/N)	N/A	N/A	DWS Offset (in)	N/A
N/A	Shared Landing?	N/A			
N/A	Gutter Ponding?	Yes	N/A	Gutter Slope (%)	N/A
N/A	Gutter Lip Ht (in)	N/A	N/A	Gutter X Slope (%)	N/A
N/A	Painted X Walk1?	No	N/A	Painted X Walk2?	No
	X Walk 1 Direction	To W		X Walk 2 Direction	To S
N/A	X Walk 1 Width (in)	N/A	N/A	X Walk 2 Width (in)	N/A
	X Walk 1 Slope (%)	0.9		X Walk 2 Slope (%)	0.2
	X Walk 1 X Slope (%)	1.1		X Walk 2 X Slope (%)	0.8

N/A	Ramp inside XWalk1?	N/A	N/A	Ramp inside XWalk2?	N/A
	Road Slope (%)	0.1	N/A	Clear Space?	N/A
	Road X Slope (%)	0.9	N/A	Clear Space to XWalk (in)	N/A
N/A	Any Obstructions?	N/A	N/A	Storm Grate/Utility Hazard?	N/A
	Obstruction Type			Storm Grate/Utility Type	
		N/A			N/A
		Yes		Surface Condition? (G/P)	Good

Remove & Replace Curb Ramp With Two New Directional Ramps or Equivalent.

Not Found, R304.5.1
