# Access Compliance Report

## Public Rights-of-Way

### (Curb Ramps)

Intersection ID: 8802	Main Street: E_W_T_HARRIS_BV	Cross Street: ST_JOHNS_CHURCH_RD	Location: NW
ADA ID: CE75C3EC0D36	Ramp Type: Directional1	Initial Pass/Fail: Fail	Overall Compliance: No
Severity Score: 13.75			
Codes/Mitigation Info/Possible Solution		Field Measurements/Component Compliance

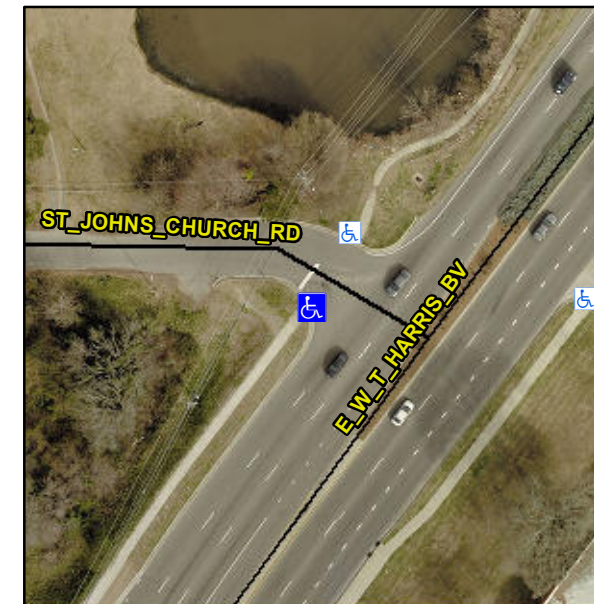
**VEGETATION OVERGROWTH**

**R304.2.2, R304.5.3**

Compliance	Description	Data	Compliance	Description	Data
N/A	Ramp Length (in)	118.0	N/A	Grade Break?	N/A
Yes	Ramp Width (in)	71.0	N/A	Grade Break Slope (%)	0.0
No	Ramp Slope (%)	10.4	N/A	Grade Break XSlope (%)	0.0
No	Ramp XSlope (%)	2.2			
N/A	Flare Type LT	N/A	N/A	Flare Type RT	N/A
N/A	Flare Slope LT (%)	N/A	N/A	Flare Slope RT (%)	0.0
N/A	Flare Traversable LT?	N/A	N/A	Flare Traversable RT?	N/A
N/A	Landing Length (in)	0.0	N/A	DWS Provided?	N/A
N/A	Landing Width (in)	0.0	N/A	DWS Contrast?	N/A
N/A	Landing Slope (%)	0.0	N/A	DWS Length (in)	N/A
N/A	Landing X Slope (%)	0.0	N/A	DWS Full Width?	N/A
N/A	Landing Curb? (Y/N)	N/A	N/A	DWS Offset LT (in)	N/A
N/A	Shared Landing?	N/A	N/A	DWS Offset RT (in)	N/A
N/A	Gutter Ponding?	0.0	N/A	Gutter Slope (%)	N/A
N/A	Gutter Lip Ht (in)	0.5	N/A	Gutter X Slope (%)	N/A
N/A	Painted X Walk1?	No		Road Slope (%)	1.0
	X Walk 1 Direction	To NE		Road X Slope (%)	6.4
	X Walk 1 Width (in)	N/A		Clear Space?	N/A

X Walk 1 Slope (%)	1.0	N/A	Clear Space to XWalk (in)	N/A
	X Walk 1 X Slope (%)	6.4	N/A	Storm Grate/Utility Hazard?	N/A
N/A	Ramp inside XWalk1?	N/A		Storm Grate/Utility Type	
N/A	Any Obstructions?	N/A			N/A
	Obstruction Type		Yes	Surface Condition? (G/P)	Good
			N/A	Curb Slope (%)	11.6

**Remove & Replace Entire Ramp.**
