# Access Compliance Report

## Public Rights-of-Way

### (Curb Ramps)

Intersection ID: 29394	Main Street: AMBERGLADES_LN	Cross Street: GARDENIA_ST	Location: SE
ADA ID: CE77F39A43D3	Ramp Type: PerpDiag	Initial Pass/Fail: Fail	Overall Compliance: No
Severity Score: 33.75			
Codes/Mitigation Info/Possible Solution		Field Measurements/Component Compliance

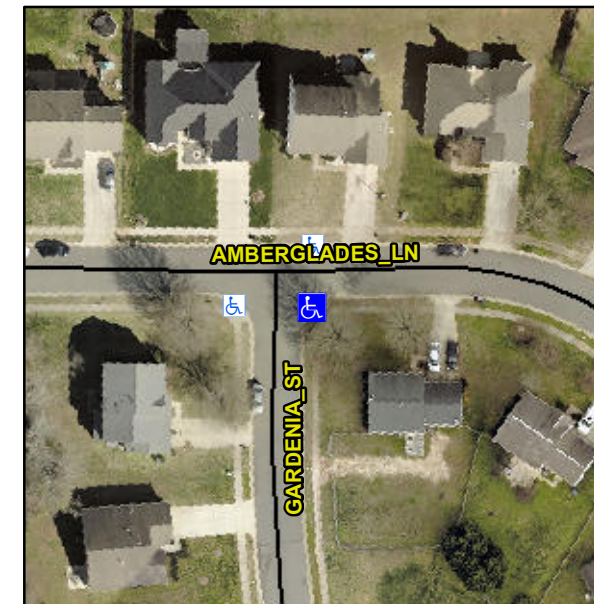
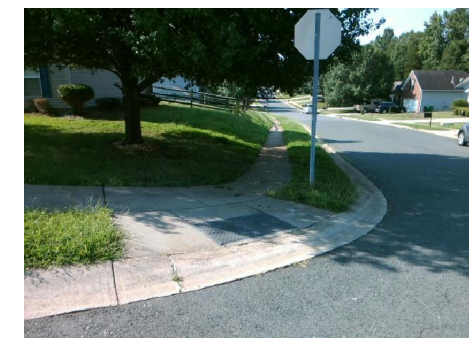
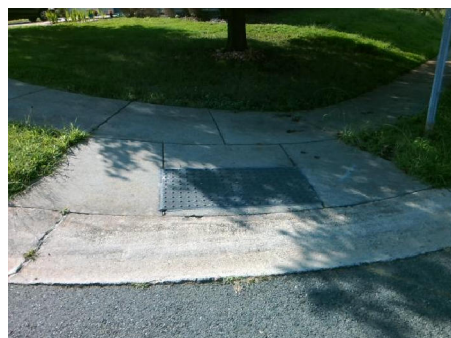
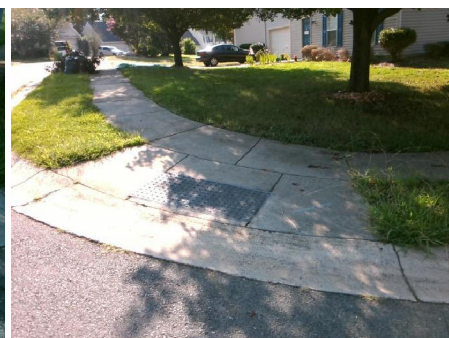
**Not Found, R304.5.1, R304.5.3**

Compliance	Description	Data	Compliance	Description	Data
N/A	Ramp Length (in)	48.5	Yes	Ramp Slope (%)	5.1
No	Ramp Width (in)	47.0	No	Ramp XSlope (%)	11.2
N/A	Flare Type LT	N/A	N/A	Flare Type RT	N/A
N/A	Flare Slope LT (%)	N/A	N/A	Flare Slope RT (%)	N/A
N/A	Flare Traversable LT?	N/A	N/A	Flare Traversable RT?	N/A
N/A	Landing Length (in)	N/A	N/A	DWS Provided?	N/A
N/A	Landing Width (in)	N/A	N/A	DWS Contrast?	N/A
N/A	Landing Slope (%)	N/A	N/A	DWS Length (in)	N/A
N/A	Landing X Slope (%)	N/A	N/A	DWS Full Width?	N/A
N/A	Landing Curb? (Y/N)	N/A	N/A	DWS Offset (in)	N/A
N/A	Shared Landing?	N/A			
N/A	Gutter Ponding?	N/A	N/A	Gutter Slope (%)	N/A
N/A	Gutter Lip Ht (in)	0.5	N/A	Gutter X Slope (%)	N/A
N/A	Painted X Walk1?	No	N/A	Painted X Walk2?	No
	X Walk 1 Direction	To N		X Walk 2 Direction	To W
N/A	X Walk 1 Width (in)	N/A	N/A	X Walk 2 Width (in)	N/A
	X Walk 1 Slope (%)	4.1		X Walk 2 Slope (%)	2.3
	X Walk 1 X Slope (%)	6.4		X Walk 2 X Slope (%)	7.4

N/A	Ramp inside XWalk1?	N/A	N/A	Ramp inside XWalk2?	N/A
	Road Slope (%)	8.4	N/A	Clear Space?	N/A
	Road X Slope (%)	1.4	N/A	Clear Space to XWalk (in)	N/A
N/A	Any Obstructions?	N/A	N/A	Storm Grate/Utility Hazard?	N/A
	Obstruction Type			Storm Grate/Utility Type	
		N/A			N/A
		Yes		Surface Condition? (G/P)	Good

**Remove & Replace Curb Ramp With Two New Directional Ramps or Equivalent.**
