Access Compliance Report

Public Rights-of-Way

(Curb Ramps)

Intersection ID: 10031842	Main Street: MINTWORTH_AV	Cross Street: N/A	Location: SW
ADA ID: CE7BA73E5C5B	Ramp Type: Perp	Initial Pass/Fail: Fail	Overall Compliance: No
			Severity Score: 13.75

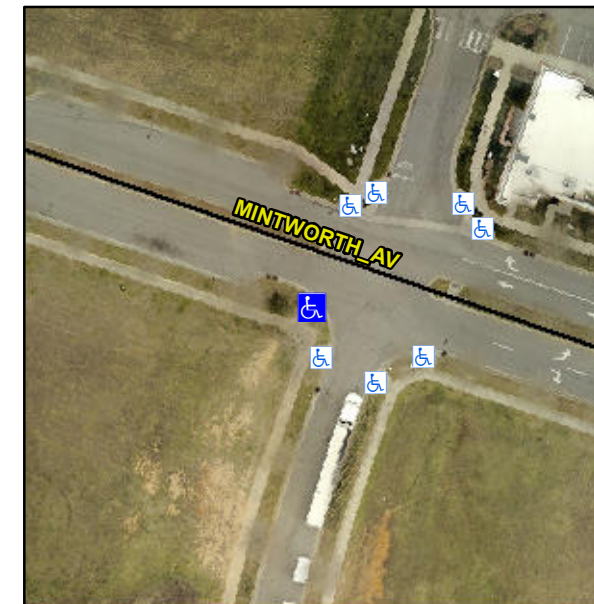
Not Found, R304.2.2, R304.5.3

Compliance	Description	Data	Compliance	Description	Data
N/A	Ramp Length (in)	70.0	No	Ramp Slope (%)	8.8
Yes	Ramp Width (in)	48.0	No	Ramp XSlope (%)	2.7
N/A	Flare Type LT	N/A	N/A	Flare Type RT	N/A
N/A	Flare Slope LT (%)	N/A	N/A	Flare Slope RT (%)	N/A
N/A	Flare Traversable LT?	N/A	N/A	Flare Traversable RT?	N/A
N/A	Landing Length (in)	N/A	N/A	DWS Provided?	N/A
N/A	Landing Width (in)	N/A	N/A	DWS Contrast?	N/A
N/A	Landing Slope (%)	N/A	N/A	DWS Length (in)	N/A
N/A	Landing X Slope (%)	N/A	N/A	DWS Full Width?	N/A
N/A	Landing Curb? (Y/N)	N/A	N/A	DWS Offset (in)	N/A
N/A	Shared Landing?	N/A			
N/A	Gutter Ponding?	N/A	N/A	Gutter Slope (%)	N/A
N/A	Gutter Lip Ht (in)	N/A	N/A	Gutter X Slope (%)	N/A
N/A	Painted X Walk1?	No	N/A	Painted X Walk2?	N/A
	X Walk 1 Direction	To NE		X Walk 2 Direction	N/A
N/A	X Walk 1 Width (in)	N/A	N/A	X Walk 2 Width (in)	N/A
	X Walk 1 Slope (%)	4.9		X Walk 2 Slope (%)	N/A
	X Walk 1 X Slope (%)	1.1		X Walk 2 X Slope (%)	N/A

N/A	Ramp inside XWalk1?	N/A	N/A	Ramp inside XWalk2?	N/A
	Road Slope (%)	N/A	N/A	Clear Space?	N/A
	Road X Slope (%)	N/A	N/A	Clear Space to XWalk (in)	N/A
N/A	Any Obstructions?	N/A	N/A	Storm Grate/Utility Hazard?	N/A
	Obstruction Type			Storm Grate/Utility Type	
			N/A		N/A
			N/A	Surface Condition? (G/P)	Fair

Remove & Replace Entire Ramp.
