Access Compliance Report

Public Rights-of-Way

(Curb Ramps)

Intersection ID: 10519	Main Street: HAMILTON_ST	Cross Street: POLK_ST	Location: SW
ADA ID: CE7C481AFC76	Ramp Type: Perp	Initial Pass/Fail: Fail	Overall Compliance: No
			Severity Score: 21.25

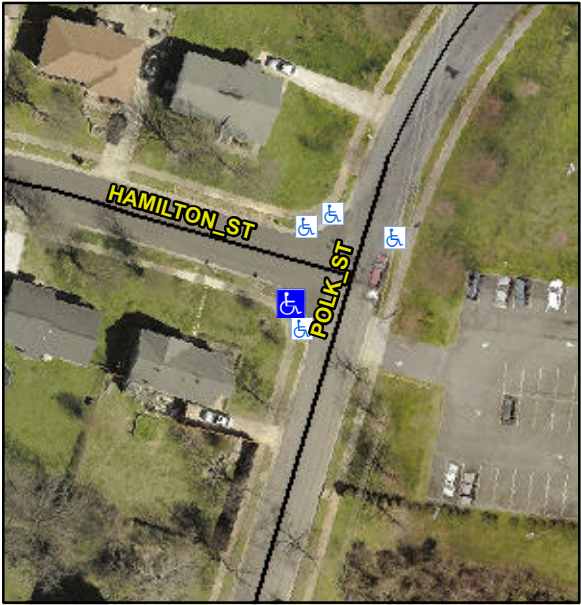
Possible Solutions:		Compliance	Description	Data
	Remove & Replace Entire Ramp.		No	Ramp Length (in)	60.0
			No	Ramp Width (in)	41.0
			N/A	Flare Type LT	N/A
			N/A	Flare Slope LT (%)	N/A
			N/A	Flare Traversable LT?	N/A
			N/A	Landing Length (in)	N/A
			N/A	Landing Width (in)	N/A
			N/A	Landing Slope (%)	N/A
			N/A	Landing X Slope (%)	N/A
<p>Surveyor Notes:</p> <p>N/A</p> <p>PROW/ADA:</p> <p>Not Found, R304.5.1, R304.2.2</p>			N/A	Flare Type RT	N/A
			N/A	Flare Slope RT (%)	N/A
			N/A	Flare Traversable RT?	N/A
			N/A	DWS Provided?	N/A
			N/A	DWS Contrast?	N/A
			N/A	DWS Length (in)	N/A
			N/A	DWS Full Width?	N/A
			N/A	DWS Offset (in)	N/A
			N/A	Shared Landing?	N/A
			N/A	Gutter Ponding?	N/A
			N/A	Gutter Lip Ht (in)	2.0
			N/A	Painted X Walk1?	No
				X Walk 1 Direction	To N
			N/A	X Walk 1 Width (in)	N/A
				X Walk 1 Slope (%)	5.7

X Walk 1 X Slope (%)	3.9
			N/A	Ramp inside XWalk1?	N/A
			N/A	Road Slope (%)	N/A
			N/A	Road X Slope (%)	N/A
			N/A	Any Obstructions?	N/A
				Obstruction Type	
			N/A		
			N/A		
			N/A		
			N/A		
			N/A		
			N/A		
			N/A		
			N/A		
			N/A		
Total Cost:		\$ 1850.00			
			N/A		
			Yes	Surface Condition? (G/P)	Good
