Intersection ID: 7017	Main Street: MCALLISTER_DR	Cross Street: DAWNSHIRE_AV	Location:	N
ADA ID: CE7C6A2F61B8	Ramp Type: Perp	Initial Pass/Fail: Fail	Overall Compliance: No	Severity Score: 21.25

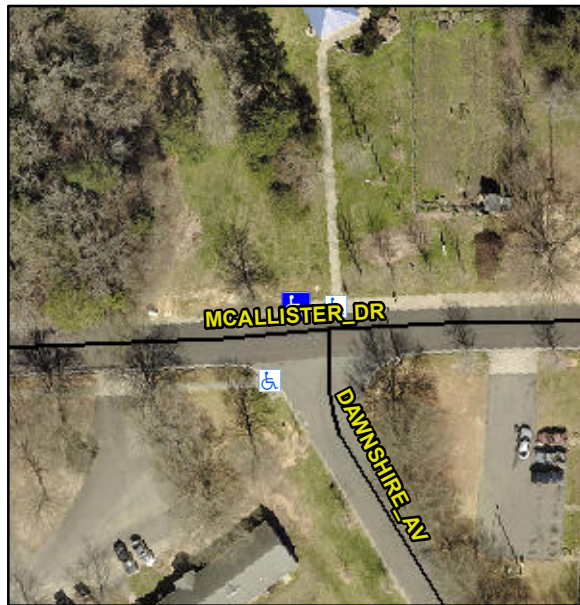
Not Found, R304.5.1, R304.5.3

Compliance	Description	Data	Compliance	Description	Data
N/A	Ramp Length (in)	28.5	Yes	Ramp Slope (%)	6.9
No	Ramp Width (in)	46.5	No	Ramp XSlope (%)	5.5
N/A	Flare Type LT	N/A	N/A	Flare Type RT	N/A
N/A	Flare Slope LT (%)	N/A	N/A	Flare Slope RT (%)	N/A
N/A	Flare Traversable LT?	N/A	N/A	Flare Traversable RT?	N/A
N/A	Landing Length (in)	N/A	N/A	DWS Provided?	N/A
N/A	Landing Width (in)	N/A	N/A	DWS Contrast?	N/A
N/A	Landing Slope (%)	N/A	N/A	DWS Length (in)	N/A
N/A	Landing X Slope (%)	N/A	N/A	DWS Full Width?	N/A
N/A	Landing Curb? (Y/N)	N/A	N/A	DWS Offset (in)	N/A
N/A	Shared Landing?	N/A			
N/A	Gutter Ponding?	N/A	N/A	Gutter Slope (%)	N/A
N/A	Gutter Lip Ht (in)	N/A	N/A	Gutter X Slope (%)	N/A
N/A	Painted X Walk1?	No	N/A	Painted X Walk2?	N/A
	X Walk 1 Direction	To SW		X Walk 2 Direction	N/A
N/A	X Walk 1 Width (in)	N/A	N/A	X Walk 2 Width (in)	N/A
	X Walk 1 Slope (%)	2.6		X Walk 2 Slope (%)	N/A
	X Walk 1 X Slope (%)	5.2		X Walk 2 X Slope (%)	N/A

N/A	Ramp inside XWalk1?	N/A	N/A	Ramp inside XWalk2?	N/A
	Road Slope (%)	N/A	N/A	Clear Space?	N/A
	Road X Slope (%)	N/A	N/A	Clear Space to XWalk (in)	N/A
N/A	Any Obstructions?	N/A	N/A	Storm Grate/Utility Hazard?	N/A
	Obstruction Type			Storm Grate/Utility Type	
		N/A			N/A
			Yes	Surface Condition? (G/P)	Good

Remove & Replace Entire Ramp.
