Intersection ID: 23151	Main Street: LAUREL_POINTE_WY	Cross Street: MOSS_RD	Location:	SW
ADA ID: CE8D0967A6D0	Ramp Type: Perp	Initial Pass/Fail: Fail	Overall Compliance: No	Severity Score: 1.25

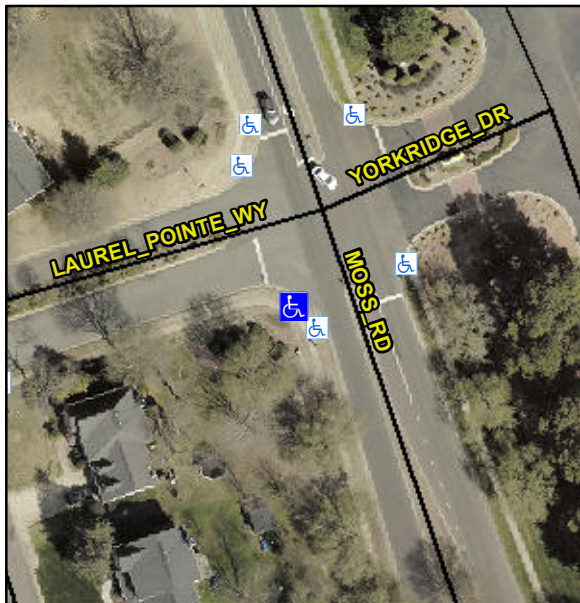
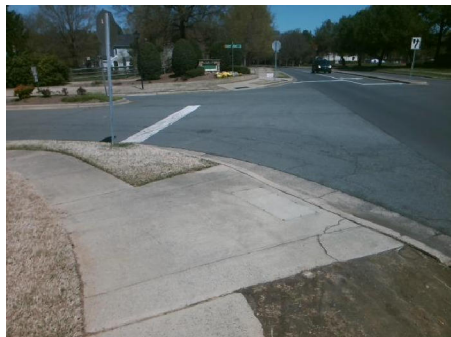
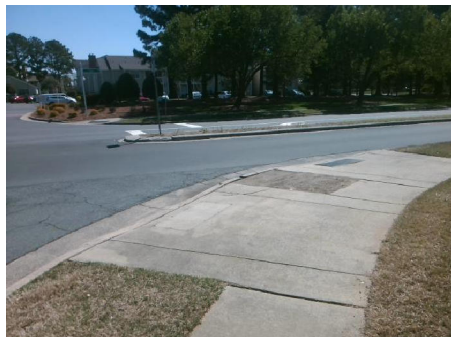
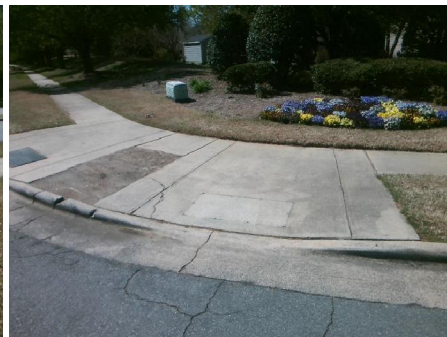
Possible Solutions:		Remove & Replace Entire Ramp.						
	Surveyor Notes:		N/A						
	PROW/ADA:		R304.5.3						
	Street 1 Name		LAUREL POINTE WY						
	Stop Condition-Street 2		StopSign						
	Street 2 Name		N/A						
	Stop Condition-Street 1		N/A						
	Total Cost:		\$ 1850.00						
				Compliance	Description	Data	Compliance	Description	Data
				N/A	Ramp Length (in)	124.0	Yes	Ramp Slope (%)	5.5
			Yes	Ramp Width (in)	48.0	No	Ramp XSlope (%)	3.9	
			N/A	Flare Type LT	N/A	N/A	Flare Type RT	N/A	
			N/A	Flare Slope LT (%)	N/A	N/A	Flare Slope RT (%)	N/A	
			N/A	Flare Traversable LT?	N/A	N/A	Flare Traversable RT?	N/A	
			N/A	Landing Length (in)	N/A	N/A	DWS Provided?	N/A	
			N/A	Landing Width (in)	N/A	N/A	DWS Contrast?	N/A	
			N/A	Landing Slope (%)	N/A	N/A	DWS Length (in)	N/A	
			N/A	Landing X Slope (%)	N/A	N/A	DWS Full Width?	N/A

N/A	Landing Curb? (Y/N)	N/A	N/A	DWS Offset (in)	N/A	
			N/A	Shared Landing?	N/A				
			N/A	Gutter Ponding?	N/A	N/A	Gutter Slope (%)	N/A	
			N/A	Gutter Lip Ht (in)	N/A	N/A	Gutter X Slope (%)	N/A	
			N/A	Painted X Walk1?	No	N/A	Painted X Walk2?	N/A	
				X Walk 1 Direction	To NW		X Walk 2 Direction	N/A	
			N/A	X Walk 1 Width (in)	N/A	N/A	X Walk 2 Width (in)	N/A	
				X Walk 1 Slope (%)	1.9		X Walk 2 Slope (%)	N/A	
				X Walk 1 X Slope (%)	1.0		X Walk 2 X Slope (%)	N/A	
			N/A	Ramp inside XWalk1?	N/A	N/A	Ramp inside XWalk2?	N/A	
				Road Slope (%)	N/A	N/A	Clear Space?	N/A	
				Road X Slope (%)	N/A	N/A	Clear Space to XWalk (in)	N/A	
			N/A	Any Obstructions?	N/A	N/A	Storm Grate/Utility Hazard?	N/A	
				Obstruction Type			Storm Grate/Utility Type		
					N/A			N/A	
						Yes	Surface Condition? (G/P)	Good
