Access Compliance Report

Public Rights-of-Way

(Curb Ramps)

Intersection ID: 53928	Main Street: PRESTON_KNOLL_LN	Cross Street: PINYON_PINE_LN	Location: SE
ADA ID: CE93C4947EFB	Ramp Type: PerpDiag	Initial Pass/Fail: Fail	Overall Compliance: No
Severity Score: 8.75			
Codes/Mitigation Info/Possible Solution		Field Measurements/Component Compliance

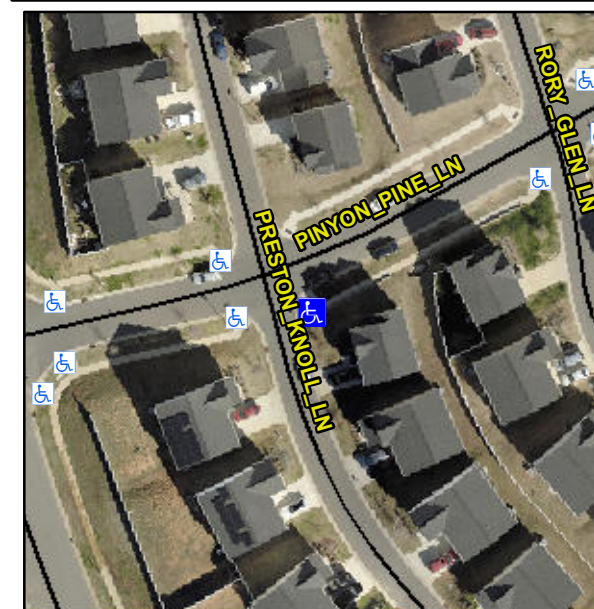
Compliance	Description	Data	Compliance	Description	Data
N/A	Ramp Length (in)	93.5	Yes	Ramp Slope (%)	7.2
No	Ramp Width (in)	36.0	Yes	Ramp XSlope (%)	0.0
N/A	Flare Type LT	N/A	N/A	Flare Type RT	N/A
N/A	Flare Slope LT (%)	N/A	N/A	Flare Slope RT (%)	N/A
N/A	Flare Traversable LT?	N/A	N/A	Flare Traversable RT?	N/A
N/A	Landing Length (in)	N/A	N/A	DWS Provided?	N/A
N/A	Landing Width (in)	N/A	N/A	DWS Contrast?	N/A
N/A	Landing Slope (%)	N/A	N/A	DWS Length (in)	N/A
N/A	Landing X Slope (%)	N/A	N/A	DWS Full Width?	N/A
N/A	Landing Curb? (Y/N)	N/A	N/A	DWS Offset (in)	N/A
N/A	Shared Landing?	N/A			
N/A	Gutter Ponding?	N/A	N/A	Gutter Slope (%)	N/A
N/A	Gutter Lip Ht (in)	N/A	N/A	Gutter X Slope (%)	N/A
N/A	Painted X Walk1?	No	N/A	Painted X Walk2?	No
	X Walk 1 Direction	To N		X Walk 2 Direction	To W
N/A	X Walk 1 Width (in)	N/A	N/A	X Walk 2 Width (in)	N/A
	X Walk 1 Slope (%)	3.6		X Walk 2 Slope (%)	8.6
	X Walk 1 X Slope (%)	3.6		X Walk 2 X Slope (%)	4.5

N/A	Ramp inside XWalk1?	N/A	N/A	Ramp inside XWalk2?	N/A
	Road Slope (%)	1.4	N/A	Clear Space?	N/A
	Road X Slope (%)	12.1	N/A	Clear Space to XWalk (in)	N/A
N/A	Any Obstructions?	N/A	N/A	Storm Grate/Utility Hazard?	N/A
	Obstruction Type			Storm Grate/Utility Type	
		N/A			N/A
			Yes	Surface Condition? (G/P)	Good

Possible Solutions:

Remove & Replace Curb Ramp With Two New Directional Ramps or Equivalent.
