Intersection ID: 10022617	Main Street: CARMEL_RD	Cross Street: N/A	Location:	SE
ADA ID: CE968969744B	Ramp Type: PerpDiag	Initial Pass/Fail: Fail	Overall Compliance: No	Severity Score: 13.75

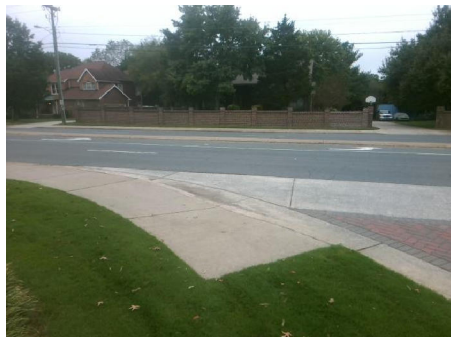
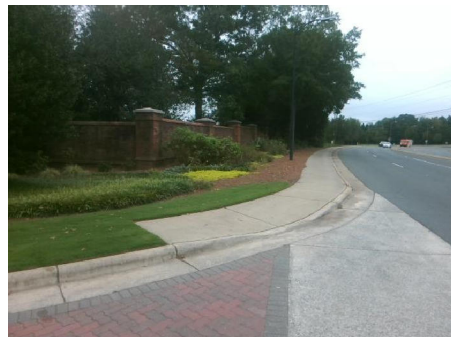
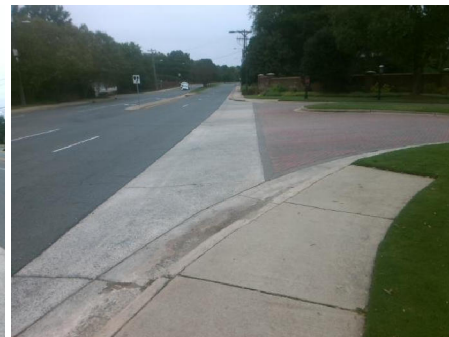
Compliance	Description	Data	Compliance	Description	Data
N/A	Ramp Length (in)	60.0	No	Ramp Slope (%)	8.6
Yes	Ramp Width (in)	48.0	No	Ramp XSlope (%)	2.9
N/A	Flare Type LT	N/A	N/A	Flare Type RT	N/A
N/A	Flare Slope LT (%)	N/A	N/A	Flare Slope RT (%)	N/A
N/A	Flare Traversable LT?	N/A	N/A	Flare Traversable RT?	N/A
N/A	Landing Length (in)	N/A	N/A	DWS Provided?	N/A
N/A	Landing Width (in)	N/A	N/A	DWS Contrast?	N/A
N/A	Landing Slope (%)	N/A	N/A	DWS Length (in)	N/A
N/A	Landing X Slope (%)	N/A	N/A	DWS Full Width?	N/A
N/A	Landing Curb? (Y/N)	N/A	N/A	DWS Offset (in)	N/A
N/A	Shared Landing?	N/A			
N/A	Gutter Ponding?	N/A	N/A	Gutter Slope (%)	N/A
N/A	Gutter Lip Ht (in)	N/A	N/A	Gutter X Slope (%)	N/A
N/A	Painted X Walk1?	No	N/A	Painted X Walk2?	No
	X Walk 1 Direction	To N		X Walk 2 Direction	To W
N/A	X Walk 1 Width (in)	N/A	N/A	X Walk 2 Width (in)	N/A
	X Walk 1 Slope (%)	2.2		X Walk 2 Slope (%)	8.9
	X Walk 1 X Slope (%)	2.3		X Walk 2 X Slope (%)	0.6

N/A	Ramp inside XWalk1?	N/A	N/A	Ramp inside XWalk2?	N/A
	Road Slope (%)	1.8	N/A	Clear Space?	N/A
	Road X Slope (%)	2.0	N/A	Clear Space to XWalk (in)	N/A
N/A	Any Obstructions?	N/A	N/A	Storm Grate/Utility Hazard?	N/A
	Obstruction Type			Storm Grate/Utility Type	
		N/A			N/A
			Yes	Surface Condition? (G/P)	Good

**Remove & Replace Curb Ramp With Two New Directional Ramps or Equivalent.**
