# Access Compliance Report

## Public Rights-of-Way

### (Curb Ramps)

Intersection ID: 11256	Main Street: 5TH_ST	Cross Street: IRWIN_RD	Location: S
ADA ID: CEA089F67912	Ramp Type: Perp	Initial Pass/Fail: Fail	Overall Compliance: No
Severity Score: 25			
Codes/Mitigation Info/Possible Solution		Field Measurements/Component Compliance

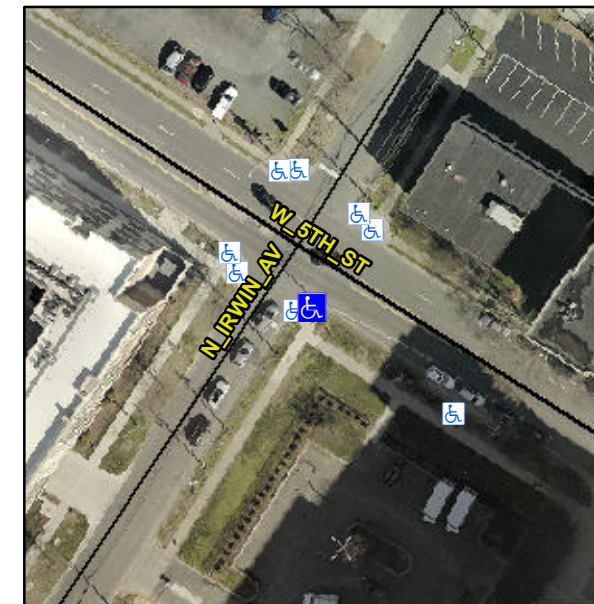
**R304.2.2, R304.5.3**

Compliance	Description	Data	Compliance	Description	Data
N/A	Ramp Length (in)	55.0	No	Ramp Slope (%)	9.5
Yes	Ramp Width (in)	60.0	No	Ramp XSlope (%)	5.7
N/A	Flare Type LT	N/A	N/A	Flare Type RT	N/A
N/A	Flare Slope LT (%)	N/A	N/A	Flare Slope RT (%)	N/A
N/A	Flare Traversable LT?	N/A	N/A	Flare Traversable RT?	N/A
N/A	Landing Length (in)	N/A	N/A	DWS Provided?	N/A
N/A	Landing Width (in)	N/A	N/A	DWS Contrast?	N/A
N/A	Landing Slope (%)	N/A	N/A	DWS Length (in)	N/A
N/A	Landing X Slope (%)	N/A	N/A	DWS Full Width?	N/A
N/A	Landing Curb? (Y/N)	N/A	N/A	DWS Offset (in)	N/A
N/A	Shared Landing?	N/A			
N/A	Gutter Ponding?	N/A	N/A	Gutter Slope (%)	N/A
N/A	Gutter Lip Ht (in)	N/A	N/A	Gutter X Slope (%)	N/A
N/A	Painted X Walk1?	No	N/A	Painted X Walk2?	N/A
	X Walk 1 Direction	To NE		X Walk 2 Direction	N/A
N/A	X Walk 1 Width (in)	N/A	N/A	X Walk 2 Width (in)	N/A
	X Walk 1 Slope (%)	4.9		X Walk 2 Slope (%)	N/A
	X Walk 1 X Slope (%)	2.6		X Walk 2 X Slope (%)	N/A

N/A	Ramp inside XWalk1?	N/A	N/A	Ramp inside XWalk2?	N/A
	Road Slope (%)	N/A	N/A	Clear Space?	N/A
	Road X Slope (%)	N/A	N/A	Clear Space to XWalk (in)	N/A
N/A	Any Obstructions?	N/A	N/A	Storm Grate/Utility Hazard?	N/A
	Obstruction Type			Storm Grate/Utility Type	
		N/A			N/A
			Yes	Surface Condition? (G/P)	Good

**Remove & Replace Entire Ramp.**

**\$ 1850.00**
