Access Compliance Report

Public Rights-of-Way

(Curb Ramps)

| Intersection ID: 15353 | Main Street: DILWORTH_RD_WEST | Cross Street: LEDGEWOOD_LN | Location: W |

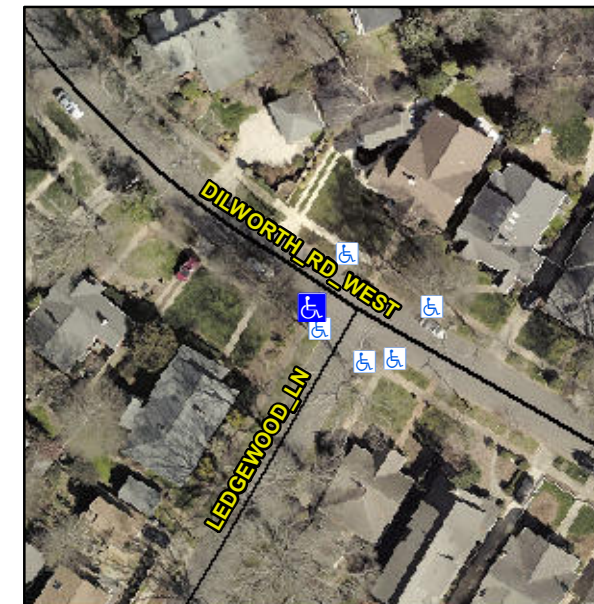
| ADA ID: CEA2D63A115F | Ramp Type: Perp | Initial Pass/Fail: Fail | Overall Compliance: No |
| Severity Score: 10 | | | |

R304.5.1, R304.5.3

| Compliance | Description | Data | Compliance | Description | Data |
|---|---|---|---|---|---|
| N/A | Ramp Length (in) | 60.0 | Yes | Ramp Slope (%) | 5.7 |
| No | Ramp Width (in) | 36.0 | No | Ramp XSlope (%) | 2.8 |

Remove & Replace Entire Ramp.

Total Cost: \$ 1850.00
