Access Compliance Report

Public Rights-of-Way

(Curb Ramps)

Intersection ID: 7354	Main Street: KIKER_CR	Cross Street: MOORES_CHAPEL_RD	Location: SW
ADA ID: CEA57721E15A	Ramp Type: Combination1	Initial Pass/Fail: Fail	Overall Compliance: No
Severity Score: 25			
Codes/Mitigation Info/Possible Solution		Field Measurements/Component Compliance

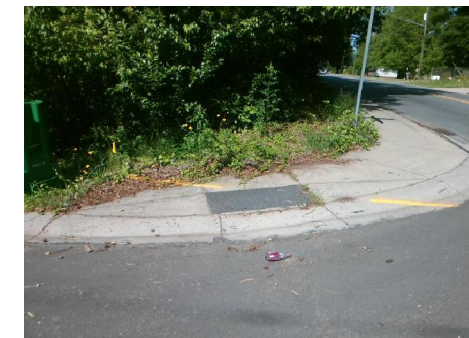
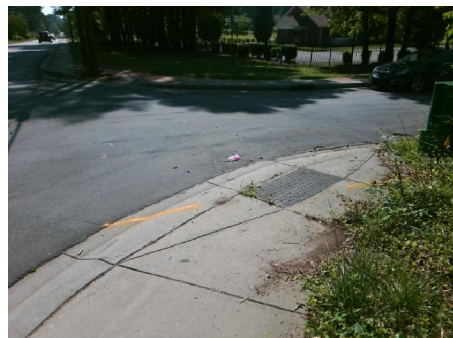
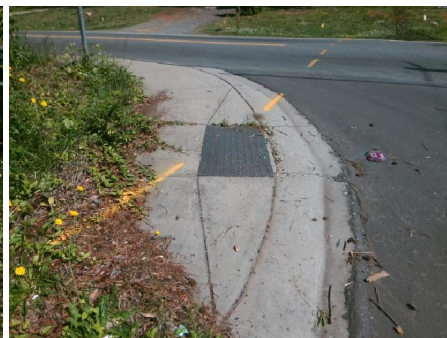
RP < 5%

Not Found, R304.5.1, R304.5.3, R304.3.2

Compliance	Description	Data	Compliance	Description	Data
N/A	Ramp Length LT (in)	N/A	N/A	Ramp Length RT (in)	55.0
N/A	Ramp Width LT (in)	N/A	Yes	Ramp Width RT (in)	58.0
N/A	Ramp Slope LT (%)	N/A	No	Ramp Slope RT (%)	9.9
N/A	Ramp XSlope LT (%)	N/A	No	Ramp XSlope RT (%)	4.5
N/A	Ramp Length (in)	58.0	Yes	Ramp Slope (%)	2.5
No	Ramp Width (in)	44.5	No	Ramp XSlope (%)	5.3
N/A	Flare Type LT	N/A	N/A	Flare Type RT	N/A
N/A	Flare Slope LT (%)	N/A	N/A	Flare Slope RT (%)	N/A
N/A	Flare Traversable LT?	N/A	N/A	Flare Traversable RT?	N/A
N/A	Landing Length (in)	N/A	N/A	DWS Provided?	N/A
N/A	Landing Width (in)	N/A	N/A	DWS Contrast?	N/A
N/A	Landing Slope (%)	N/A	N/A	DWS Length (in)	N/A
N/A	Landing X Slope (%)	N/A	N/A	DWS Full Width?	N/A
N/A	Landing Curb? (Y/N)	N/A	N/A	DWS Offset (in)	N/A
N/A	Shared Landing?	N/A			
N/A	Gutter Ponding?	N/A	N/A	Gutter Slope (%)	N/A
N/A	Gutter Lip Ht (in)	N/A	N/A	Gutter X Slope (%)	N/A
N/A	Painted X Walk1?	No	N/A	Painted X Walk2?	N/A

X Walk 1 Direction	To E		X Walk 2 Direction	N/A
	X Walk 1 Width (in)	N/A		X Walk 2 Width (in)	N/A
	X Walk 1 Slope (%)	1.5		X Walk 2 Slope (%)	N/A
	X Walk 1 X Slope (%)	4.4		X Walk 2 X Slope (%)	N/A
N/A	Ramp inside XWalk1?	N/A	N/A	Ramp inside XWalk2?	N/A
	Road Slope (%)	N/A		Clear Space?	N/A
	Road X Slope (%)	N/A	N/A	Clear Space to XWalk (in)	N/A
			N/A	Any Obstruction?	N/A
				Obstruction Type	N/A
			N/A	Storm Grate/Utility Hazard?	N/A
				Storm Grate/Utility Type	N/A
			Yes	Surface Condition? (G/P)	Good
				Curb Slope (%)	8.9

Remove & Replace Entire Ramp.
