# Access Compliance Report

## Public Rights-of-Way

### (Curb Ramps)

Intersection ID: 13304	Main Street: GOLF_COURSE_LN	Cross Street: OLD_STEELE_CREEK_RD	Location: NE
ADA ID: CEAE4002492E	Ramp Type: PerpDiag	Initial Pass/Fail: Fail	Overall Compliance: No
Severity Score: 12.5			
Codes/Mitigation Info/Possible Solution		Field Measurements/Component Compliance

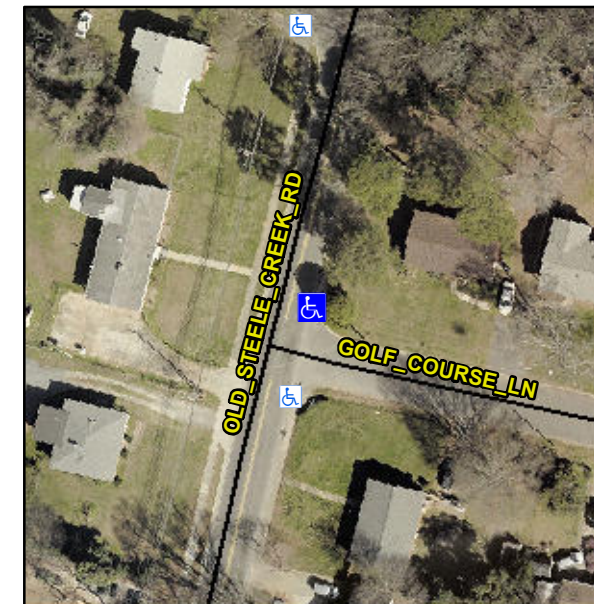
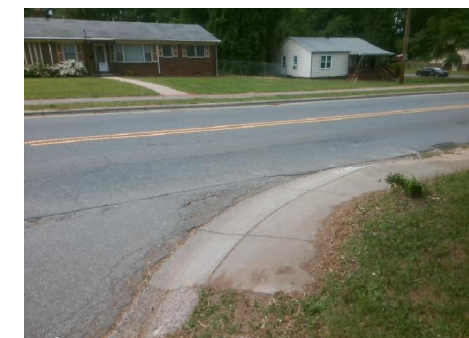
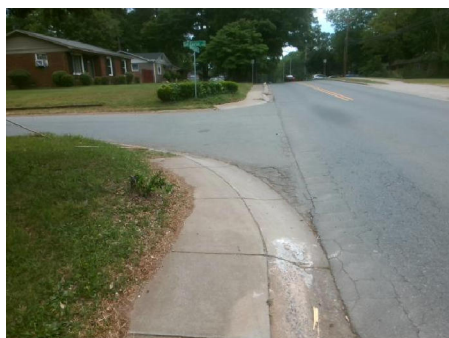
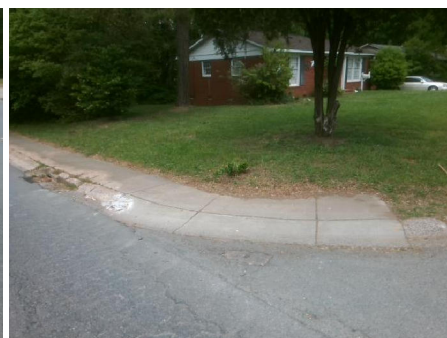
Compliance	Description	Data	Compliance	Description	Data
N/A	Ramp Length (in)	48.0	Yes	Ramp Slope (%)	6.9
Yes	Ramp Width (in)	48.0	No	Ramp XSlope (%)	5.8
N/A	Flare Type LT	N/A	N/A	Flare Type RT	N/A
N/A	Flare Slope LT (%)	N/A	N/A	Flare Slope RT (%)	N/A
N/A	Flare Traversable LT?	N/A	N/A	Flare Traversable RT?	N/A
N/A	Landing Length (in)	N/A	N/A	DWS Provided?	N/A
N/A	Landing Width (in)	N/A	N/A	DWS Contrast?	N/A
N/A	Landing Slope (%)	N/A	N/A	DWS Length (in)	N/A
N/A	Landing X Slope (%)	N/A	N/A	DWS Full Width?	N/A
N/A	Landing Curb? (Y/N)	N/A	N/A	DWS Offset (in)	N/A
N/A	Shared Landing?	N/A			
N/A	Gutter Ponding?	N/A	N/A	Gutter Slope (%)	N/A
N/A	Gutter Lip Ht (in)	N/A	N/A	Gutter X Slope (%)	N/A
N/A	Painted X Walk1?	No	N/A	Painted X Walk2?	No
	X Walk 1 Direction	To W		X Walk 2 Direction	To SW
N/A	X Walk 1 Width (in)	N/A	N/A	X Walk 2 Width (in)	N/A
	X Walk 1 Slope (%)	3.2		X Walk 2 Slope (%)	5.5
	X Walk 1 X Slope (%)	4.2		X Walk 2 X Slope (%)	0.9

N/A	Ramp inside XWalk1?	N/A	N/A	Ramp inside XWalk2?	N/A
	Road Slope (%)	1.8	N/A	Clear Space?	N/A
	Road X Slope (%)	3.7	N/A	Clear Space to XWalk (in)	N/A
N/A	Any Obstructions?	N/A	N/A	Storm Grate/Utility Hazard?	N/A
	Obstruction Type			Storm Grate/Utility Type	
		N/A			N/A
			Yes	Surface Condition? (G/P)	Good

**Remove & Replace Curb Ramp With Two New Directional Ramps or Equivalent.**

**Not Found, R304.5.3**
