# Access Compliance Report

## Public Rights-of-Way

### (Curb Ramps)

Intersection ID: 28216	Main Street: JAMES_RICHARD_DR	Cross Street: PEPPERWICH_PL	Location: NE
ADA ID: CEC0D1DC93AD	Ramp Type: Perp	Initial Pass/Fail: Fail	Overall Compliance: No
		Severity Score: 1.25

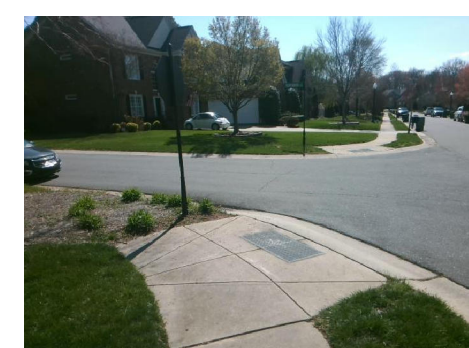
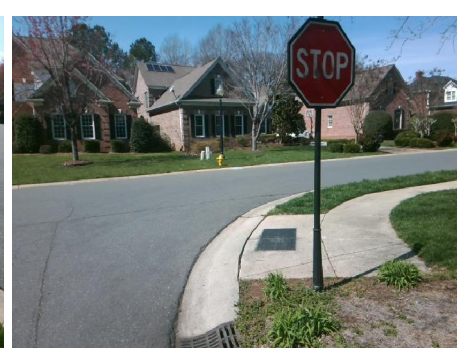
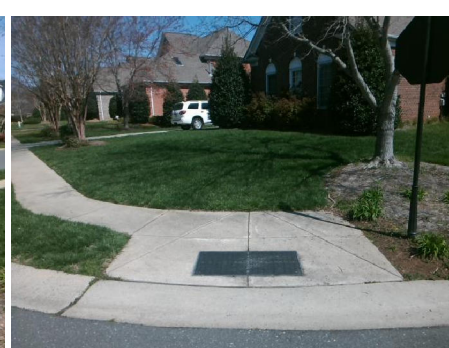
Possible Solutions:		<b>Compliance</b>	<b>Description</b>	<b>Data</b>
	<b>Remove &amp; Replace Entire Ramp.</b>		<b>N/A</b>	Ramp Length (in)	<b>48.0</b>
			<b>Yes</b>	Ramp Width (in)	<b>48.0</b>
			<b>N/A</b>	Flare Type LT	<b>N/A</b>
			<b>N/A</b>	Flare Slope LT (%)	<b>N/A</b>
			<b>N/A</b>	Flare Traversable LT?	<b>N/A</b>
			<b>N/A</b>	Landing Length (in)	<b>N/A</b>
			<b>N/A</b>	Landing Width (in)	<b>N/A</b>
			<b>N/A</b>	Landing Slope (%)	<b>N/A</b>
			<b>N/A</b>	Landing X Slope (%)	<b>N/A</b>
<p>Surveyor Notes:</p> <p><b>N/A</b></p> <p>PROW/ADA:</p> <p><b>Not Found, R304.5.3</b></p>			<b>N/A</b>	Flare Type RT	<b>N/A</b>
			<b>N/A</b>	Flare Slope RT (%)	<b>N/A</b>
			<b>N/A</b>	Flare Traversable RT?	<b>N/A</b>
			<b>N/A</b>	DWS Provided?	<b>N/A</b>
			<b>N/A</b>	DWS Contrast?	<b>N/A</b>
			<b>N/A</b>	DWS Length (in)	<b>N/A</b>

<b>N/A</b>	DWS Full Width?	<b>N/A</b>
			<b>N/A</b>	DWS Offset (in)	<b>N/A</b>
			<b>N/A</b>	Gutter Ponding?	<b>N/A</b>
			<b>N/A</b>	Gutter Lip Ht (in)	<b>N/A</b>
			<b>N/A</b>	Painted X Walk1?	<b>No</b>
				X Walk 1 Direction	<b>To SW</b>
			<b>N/A</b>	X Walk 1 Width (in)	<b>N/A</b>
				X Walk 1 Slope (%)	<b>0.1</b>
				X Walk 1 X Slope (%)	<b>1.0</b>
			<b>N/A</b>	Ramp inside XWalk1?	<b>N/A</b>
			<b>N/A</b>	Road Slope (%)	<b>N/A</b>
			<b>N/A</b>	Road X Slope (%)	<b>N/A</b>
			<b>N/A</b>	Any Obstructions?	<b>N/A</b>
				Obstruction Type	
Total Cost:		<b>\$ 1850.00</b>			
			<b>N/A</b>		<b>N/A</b>
			<b>Yes</b>	Surface Condition? (G/P)	<b>Good</b>
