# Access Compliance Report

## Public Rights-of-Way

### (Curb Ramps)

Intersection ID: 10599	Main Street: BARRINGTON_DR	Cross Street: BELLE_PLAINE_DR	Location: NW
ADA ID: CEC5FF159CFE	Ramp Type: Perp	Initial Pass/Fail: Fail	Overall Compliance: No
Severity Score: 37.5			
Codes/Mitigation Info/Possible Solution		Field Measurements/Component Compliance

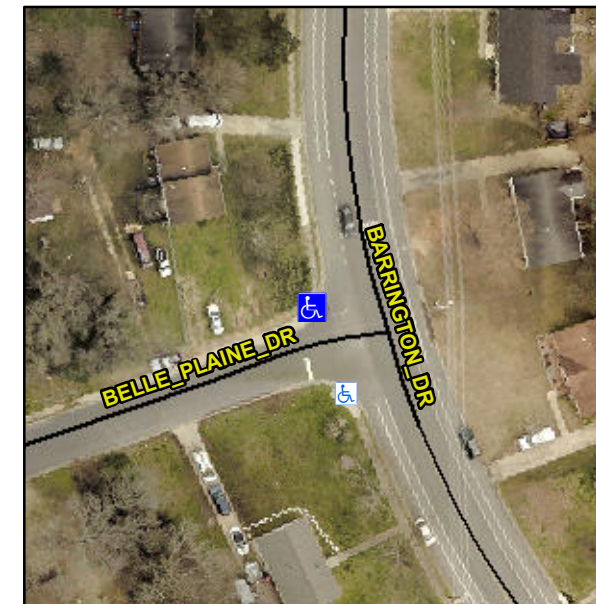
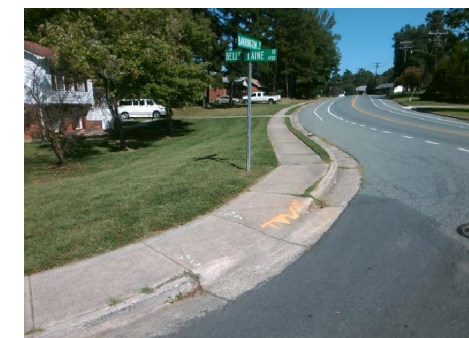
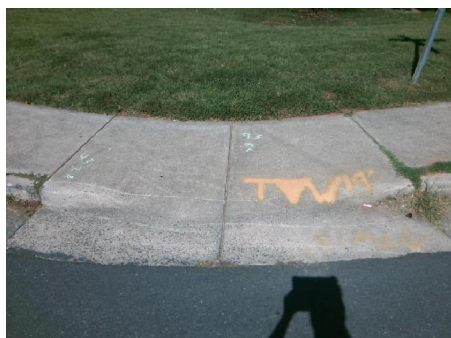
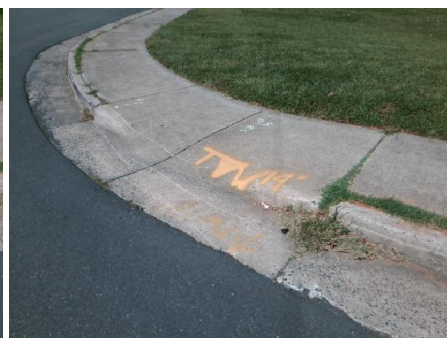
**Not Found, R304.2.2, R304.5.3**

Compliance	Description	Data	Compliance	Description	Data
N/A	Ramp Length (in)	43.0	No	Ramp Slope (%)	8.6
Yes	Ramp Width (in)	62.0	No	Ramp XSlope (%)	9.5
N/A	Flare Type LT	N/A	N/A	Flare Type RT	N/A
N/A	Flare Slope LT (%)	N/A	N/A	Flare Slope RT (%)	N/A
N/A	Flare Traversable LT?	N/A	N/A	Flare Traversable RT?	N/A
N/A	Landing Length (in)	N/A	N/A	DWS Provided?	N/A
N/A	Landing Width (in)	N/A	N/A	DWS Contrast?	N/A
N/A	Landing Slope (%)	N/A	N/A	DWS Length (in)	N/A
N/A	Landing X Slope (%)	N/A	N/A	DWS Full Width?	N/A
N/A	Landing Curb? (Y/N)	N/A	N/A	DWS Offset (in)	N/A
N/A	Shared Landing?	N/A			
N/A	Gutter Ponding?	N/A	N/A	Gutter Slope (%)	N/A
N/A	Gutter Lip Ht (in)	0.5	N/A	Gutter X Slope (%)	N/A
N/A	Painted X Walk1?	No	N/A	Painted X Walk2?	N/A
	X Walk 1 Direction	To S		X Walk 2 Direction	N/A
N/A	X Walk 1 Width (in)	N/A	N/A	X Walk 2 Width (in)	N/A
	X Walk 1 Slope (%)	2.8		X Walk 2 Slope (%)	N/A
	X Walk 1 X Slope (%)	4.3		X Walk 2 X Slope (%)	N/A

N/A	Ramp inside XWalk1?	N/A	N/A	Ramp inside XWalk2?	N/A
	Road Slope (%)	N/A	N/A	Clear Space?	N/A
	Road X Slope (%)	N/A	N/A	Clear Space to XWalk (in)	N/A
N/A	Any Obstructions?	N/A	N/A	Storm Grate/Utility Hazard?	N/A
	Obstruction Type			Storm Grate/Utility Type	
		N/A			N/A
		Yes		Surface Condition? (G/P)	Good

**Remove & Replace Entire Ramp.**

Total Cost: \$ 1850.00
