Access Compliance Report Public Rights-of-Way (Curb Ramps)

Intersection ID: N/A Main Street: SOUTH BV **Cross Street: N/A** Location: NE **ADA ID: CED016BD3848** Ramp Type: PerpDiag Initial Pass/Fail: Fail **Overall Compliance: No Severity Score:** 50

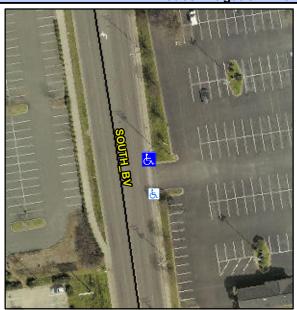
SOUTH BV Street 1 Name Stop Condition-Street 2 None Street 2 Name **ENTRANCE** Stop Condition-Street 1 None

Yes	Ramp Width (in)	48.0	No	Ramp XSlope (%)	8.1
N/A	Flare Type LT	N/A	N/A	Flare Type RT	N/A
N/A	Flare Slope LT (%)	N/A	N/A	Flare Slope RT (%)	N/A
N/A	Flare Traversable LT?	N/A	N/A	Flare Traversable RT?	N/A
N/A	Landing Length (in)	N/A	N/A	DWS Provided?	N/A
N/A	Landing Width (in)	N/A	N/A	DWS Contrast?	N/A
N/A	Landing Slope (%)	N/A	N/A	DWS Length (in)	N/A
N/A	Landing X Slope (%)	N/A	N/A	DWS Full Width?	N/A
N/A	Landing Curb? (Y/N)	N/A	N/A	DWS Offset (in)	N/A
N/A	Shared Landing?	N/A			
N/A	Gutter Ponding?	N/A	N/A	Gutter Slope (%)	N/A
N/A	Gutter Lip Ht (in)	N/A	N/A	Gutter X Slope (%)	N/A
N/A	Painted X Walk1?	No	N/A	Painted X Walk2?	No
	X Walk 1 Direction	To W		X Walk 2 Direction	To S
N/A	X Walk 1 Width (in)	N/A	N/A	X Walk 2 Width (in)	N/A
	X Walk 1 Slope (%)	2.5		X Walk 2 Slope (%)	1.4
	X Walk 1 X Slope (%)	0.1		X Walk 2 X Slope (%)	13.3
N/A	Ramp inside XWalk1?	N/A	N/A	Ramp inside XWalk2?	N/A
	Road Slope (%)	7.7	N/A	Clear Space?	N/A

Road X Slope (%)	2.4	N/A	Clear Space to XWalk (in)	N/A
N/A	Any Obstructions?	N/A	N/A	Storm Grate/Utility Hazard?	N/A
	Obstruction Type			Storm Grate/Utility Type	
		N/A			N/A
			Yes	Surface Condition? (G/P)	Good

Possible Solutions: Compliance Description Remove & Replace Curb Ramp With N/A Two New Directional Ramps or Equivalent. Surveyor Notes: N/A PROW/ADA: Not Found, R304.2.2, R304.5.3
