Access Compliance Report

Public Rights-of-Way

(Curb Ramps)

Intersection ID: 10627	Main Street: TACOMA_ST	Cross Street: QUEEN_CITY_DR	Location:	N/A
ADA ID: CED621D31F65	Ramp Type: Perp	Initial Pass/Fail: Fail	Overall Compliance: No	Severity Score: 33.75
Codes/Mitigation Info/Possible Solution		Field Measurements/Component Compliance

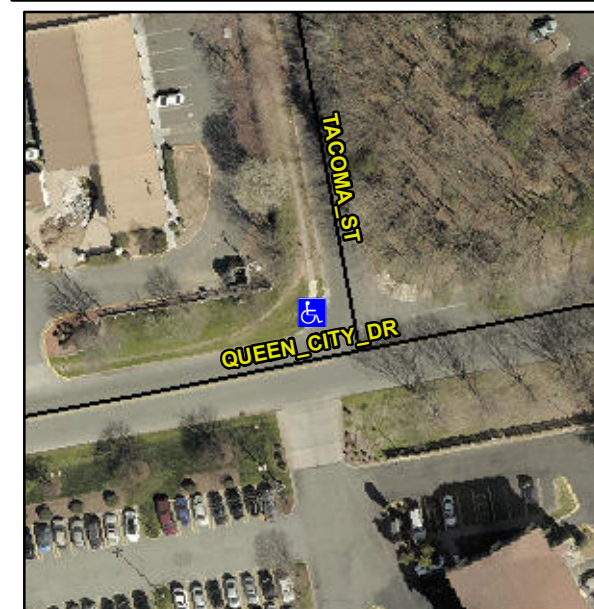
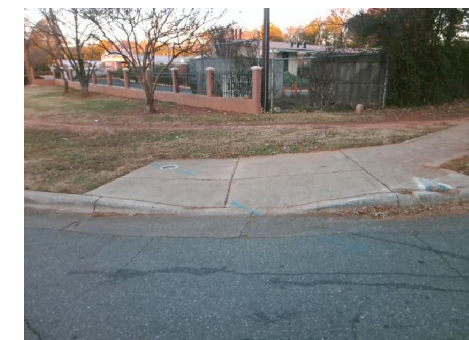
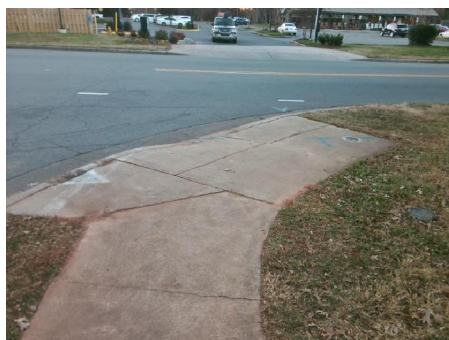
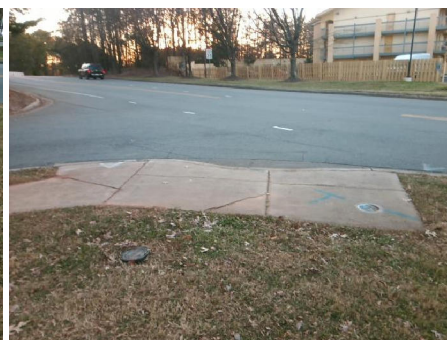
Not Found, R304.5.1, R304.2.2, R304.5.3

Compliance	Description	Data	Compliance	Description	Data
N/A	Ramp Length (in)	35.0	No	Ramp Slope (%)	11.7
No	Ramp Width (in)	40.0	No	Ramp XSlope (%)	6.0
N/A	Flare Type LT	N/A	N/A	Flare Type RT	N/A
N/A	Flare Slope LT (%)	N/A	N/A	Flare Slope RT (%)	N/A
N/A	Flare Traversable LT?	N/A	N/A	Flare Traversable RT?	N/A
N/A	Landing Length (in)	N/A	N/A	DWS Provided?	N/A
N/A	Landing Width (in)	N/A	N/A	DWS Contrast?	N/A
N/A	Landing Slope (%)	N/A	N/A	DWS Length (in)	N/A
N/A	Landing X Slope (%)	N/A	N/A	DWS Full Width?	N/A
N/A	Landing Curb? (Y/N)	N/A	N/A	DWS Offset (in)	N/A
N/A	Shared Landing?	N/A			
N/A	Gutter Ponding?	N/A	N/A	Gutter Slope (%)	N/A
N/A	Gutter Lip Ht (in)	N/A	N/A	Gutter X Slope (%)	N/A
N/A	Painted X Walk1?	No	N/A	Painted X Walk2?	N/A
	X Walk 1 Direction	To S		X Walk 2 Direction	N/A
N/A	X Walk 1 Width (in)	N/A	N/A	X Walk 2 Width (in)	N/A
	X Walk 1 Slope (%)	0.5		X Walk 2 Slope (%)	N/A
	X Walk 1 X Slope (%)	3.8		X Walk 2 X Slope (%)	N/A

N/A	Ramp inside XWalk1?	N/A	N/A	Ramp inside XWalk2?	N/A
	Road Slope (%)	3.8	N/A	Clear Space?	N/A
	Road X Slope (%)	0.5	N/A	Clear Space to XWalk (in)	N/A
N/A	Any Obstructions?	N/A	N/A	Storm Grate/Utility Hazard?	N/A
	Obstruction Type			Storm Grate/Utility Type	
		N/A			N/A
			Yes	Surface Condition? (G/P)	Good

Remove & Replace Entire Ramp.
