# Access Compliance Report

## Public Rights-of-Way

### (Curb Ramps)

Intersection ID: N/A	Main Street: PROVIDENCE_RD	Cross Street: N/A	Location: N
ADA ID: CED83BF0ACC8	Ramp Type: PerpDiag	Initial Pass/Fail: Fail	Overall Compliance: No
Codes/Mitigation Info/Possible Solution		Field Measurements/Component Compliance

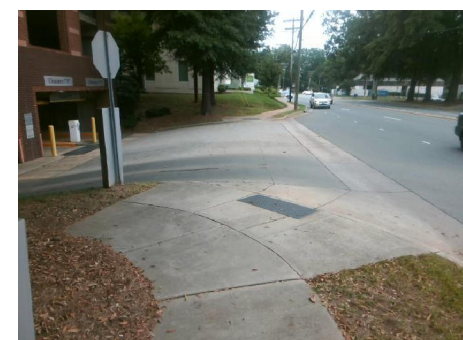
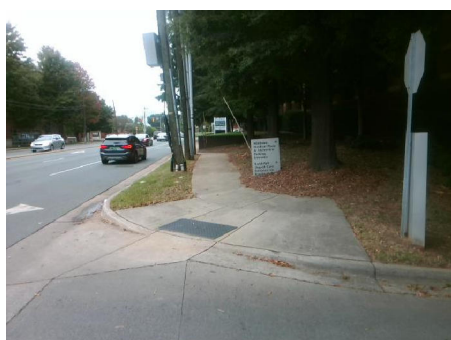
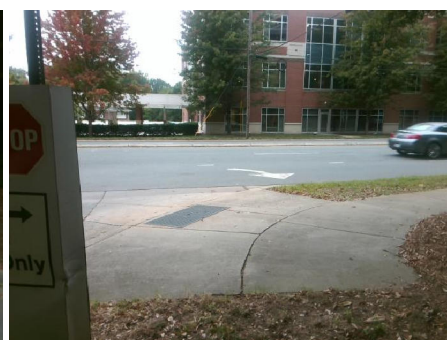
**Not Found, R304.5.1, R304.5.3**

Compliance	Description	Data	Compliance	Description	Data
N/A	Ramp Length (in)	68.0	Yes	Ramp Slope (%)	7.6
No	Ramp Width (in)	36.0	No	Ramp XSlope (%)	2.2
N/A	Flare Type LT	N/A	N/A	Flare Type RT	N/A
N/A	Flare Slope LT (%)	N/A	N/A	Flare Slope RT (%)	N/A
N/A	Flare Traversable LT?	N/A	N/A	Flare Traversable RT?	N/A
N/A	Landing Length (in)	N/A	N/A	DWS Provided?	N/A
N/A	Landing Width (in)	N/A	N/A	DWS Contrast?	N/A
N/A	Landing Slope (%)	N/A	N/A	DWS Length (in)	N/A
N/A	Landing X Slope (%)	N/A	N/A	DWS Full Width?	N/A
N/A	Landing Curb? (Y/N)	N/A	N/A	DWS Offset (in)	N/A
N/A	Shared Landing?	N/A			
N/A	Gutter Ponding?	N/A	N/A	Gutter Slope (%)	N/A
N/A	Gutter Lip Ht (in)	N/A	N/A	Gutter X Slope (%)	N/A
N/A	Painted X Walk1?	No	N/A	Painted X Walk2?	No
	X Walk 1 Direction	To SW		X Walk 2 Direction	To SE
N/A	X Walk 1 Width (in)	N/A	N/A	X Walk 2 Width (in)	N/A
	X Walk 1 Slope (%)	7.8		X Walk 2 Slope (%)	7.5
	X Walk 1 X Slope (%)	3.8		X Walk 2 X Slope (%)	4.0

N/A	Ramp inside XWalk1?	N/A	N/A	Ramp inside XWalk2?	N/A
	Road Slope (%)	4.4	N/A	Clear Space?	N/A
	Road X Slope (%)	5.0	N/A	Clear Space to XWalk (in)	N/A
N/A	Any Obstructions?	N/A	N/A	Storm Grate/Utility Hazard?	N/A
	Obstruction Type			Storm Grate/Utility Type	
		N/A			N/A
			Yes	Surface Condition? (G/P)	Good

**Remove & Replace Curb Ramp With Two New Directional Ramps or Equivalent.**
