Access Compliance Report

Public Rights-of-Way

(Curb Ramps)

Intersection ID: N/A	Main Street: AGNEW_DR	Cross Street: SOLAR_WY	Location: SW
ADA ID: CEDCD0B573D4	Ramp Type: Perp	Initial Pass/Fail: Fail	Overall Compliance: No
Codes/Mitigation Info/Possible Solution		Field Measurements/Component Compliance	
Severity Score: 10

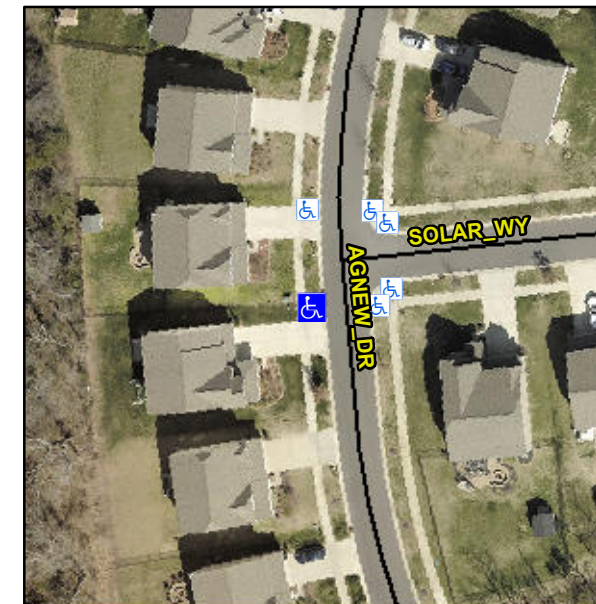
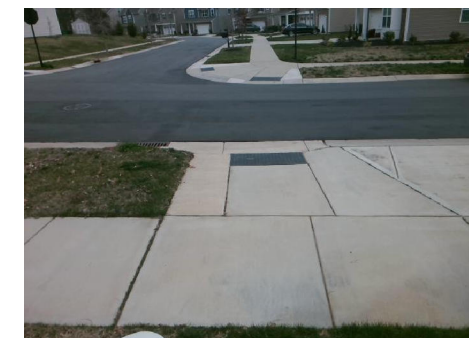
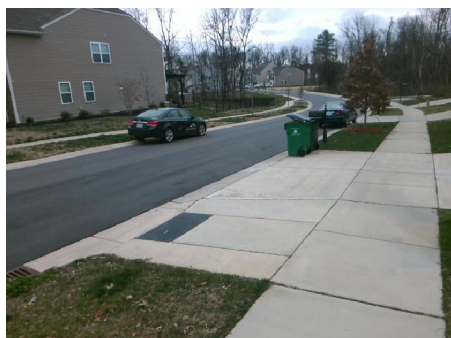
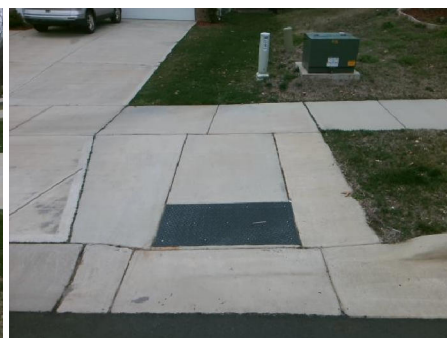
Compliance	Description	Data	Compliance	Description	Data
N/A	Ramp Length (in)	94.0	Yes	Ramp Slope (%)	6.2
No	Ramp Width (in)	47.0	Yes	Ramp XSlope (%)	3.3
N/A	Flare Type LT	N/A	N/A	Flare Type RT	N/A
N/A	Flare Slope LT (%)	N/A	N/A	Flare Slope RT (%)	N/A
N/A	Flare Traversable LT?	N/A	N/A	Flare Traversable RT?	N/A
N/A	Landing Length (in)	N/A	N/A	DWS Provided?	N/A
N/A	Landing Width (in)	N/A	N/A	DWS Contrast?	N/A
N/A	Landing Slope (%)	N/A	N/A	DWS Length (in)	N/A
N/A	Landing X Slope (%)	N/A	N/A	DWS Full Width?	N/A
N/A	Landing Curb? (Y/N)	N/A	N/A	DWS Offset (in)	N/A
N/A	Shared Landing?	N/A			
N/A	Gutter Ponding?	N/A	N/A	Gutter Slope (%)	N/A
N/A	Gutter Lip Ht (in)	N/A	N/A	Gutter X Slope (%)	N/A
N/A	Painted X Walk1?	No	N/A	Painted X Walk2?	N/A
	X Walk 1 Direction	To E		X Walk 2 Direction	N/A
N/A	X Walk 1 Width (in)	N/A	N/A	X Walk 2 Width (in)	N/A
	X Walk 1 Slope (%)	2.2		X Walk 2 Slope (%)	N/A
	X Walk 1 X Slope (%)	4.2		X Walk 2 X Slope (%)	N/A

N/A	Ramp inside XWalk1?	N/A	N/A	Ramp inside XWalk2?	N/A
	Road Slope (%)	N/A	N/A	Clear Space?	N/A
	Road X Slope (%)	N/A	N/A	Clear Space to XWalk (in)	N/A
N/A	Any Obstructions?	N/A	N/A	Storm Grate/Utility Hazard?	N/A
	Obstruction Type			Storm Grate/Utility Type	
		N/A			N/A
		Yes		Surface Condition? (G/P)	Good

Remove & Replace Entire Ramp.

R304.5.1
