Access Compliance Report

Public Rights-of-Way

(Curb Ramps)

Intersection ID: 10023378	Main Street: CHINA GROVE CHURCH RD	Cross Street: N/A	Location: SE
ADA ID: CEE081E4470F	Ramp Type: PerpDiag	Initial Pass/Fail: Fail	Overall Compliance: No
Codes/Mitigation Info/Possible Solution		Field Measurements/Component Compliance	
Severity Score: 21.25

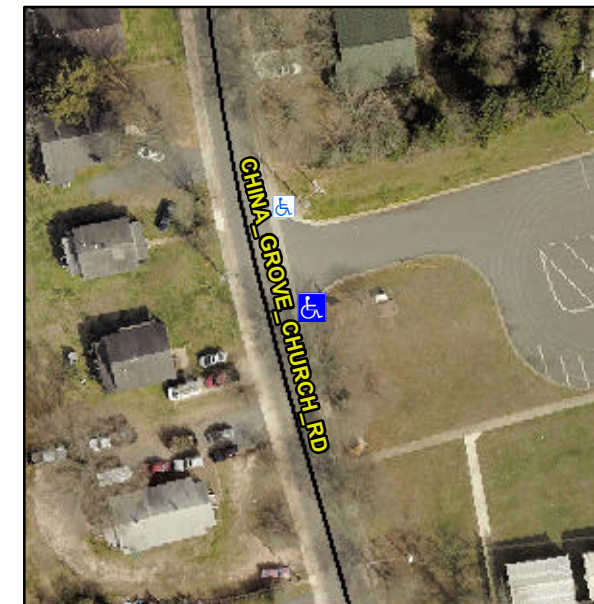
Not Found, R304.5.1, R304.2.2

Compliance	Description	Data	Compliance	Description	Data
N/A	Ramp Length (in)	63.0	No	Ramp Slope (%)	8.7
No	Ramp Width (in)	44.0	Yes	Ramp XSlope (%)	1.2
N/A	Flare Type LT	N/A	N/A	Flare Type RT	N/A
N/A	Flare Slope LT (%)	N/A	N/A	Flare Slope RT (%)	N/A
N/A	Flare Traversable LT?	N/A	N/A	Flare Traversable RT?	N/A
N/A	Landing Length (in)	N/A	N/A	DWS Provided?	N/A
N/A	Landing Width (in)	N/A	N/A	DWS Contrast?	N/A
N/A	Landing Slope (%)	N/A	N/A	DWS Length (in)	N/A
N/A	Landing X Slope (%)	N/A	N/A	DWS Full Width?	N/A
N/A	Landing Curb? (Y/N)	N/A	N/A	DWS Offset (in)	N/A
N/A	Shared Landing?	N/A			
N/A	Gutter Ponding?	N/A	N/A	Gutter Slope (%)	N/A
N/A	Gutter Lip Ht (in)	N/A	N/A	Gutter X Slope (%)	N/A
N/A	Painted X Walk1?	No	N/A	Painted X Walk2?	No
	X Walk 1 Direction	To N		X Walk 2 Direction	To W
N/A	X Walk 1 Width (in)	N/A	N/A	X Walk 2 Width (in)	N/A
	X Walk 1 Slope (%)	0.9		X Walk 2 Slope (%)	1.4
	X Walk 1 X Slope (%)	2.5		X Walk 2 X Slope (%)	1.2

N/A	Ramp inside XWalk1?	N/A	N/A	Ramp inside XWalk2?	N/A
	Road Slope (%)	1.3	N/A	Clear Space?	N/A
	Road X Slope (%)	0.8	N/A	Clear Space to XWalk (in)	N/A
N/A	Any Obstructions?	N/A	N/A	Storm Grate/Utility Hazard?	N/A
	Obstruction Type			Storm Grate/Utility Type	
		N/A			N/A
			Yes	Surface Condition? (G/P)	Good

Possible Solutions:

Remove & Replace Curb Ramp With Two New Directional Ramps or Equivalent.
