# Access Compliance Report

## Public Rights-of-Way

### (Curb Ramps)

Intersection ID: 23784	Main Street: E WESTINGHOUSE BV	Cross Street: NATIONS_FORD_RD	Location: NW
ADA ID: CEE1A0FB6B12	Ramp Type: Perp	Initial Pass/Fail: Fail	Overall Compliance: No
			Severity Score: 13.75

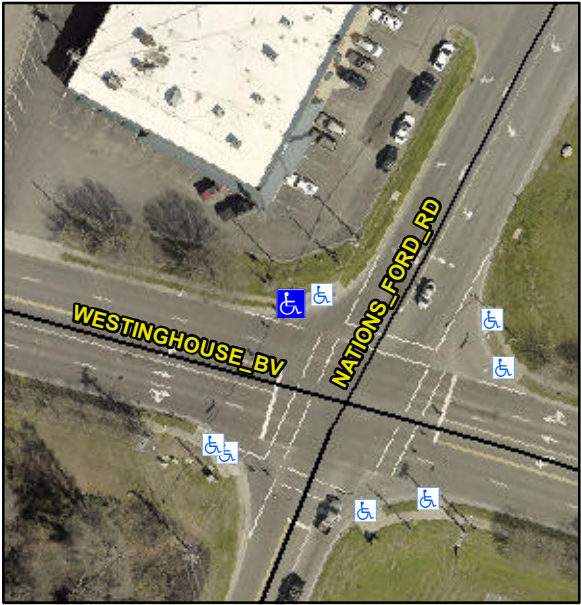
Possible Solutions:		<b>Compliance</b>	<b>Description</b>	<b>Data</b>
	<b>Remove &amp; Replace Entire Ramp.</b>		<b>No</b>	Ramp Length (in)	77.0
	<b>Restripe Crosswalk.</b>		<b>No</b>	Ramp Width (in)	51.0
			<b>N/A</b>	Flare Type LT	N/A
			<b>N/A</b>	Flare Slope LT (%)	N/A
			<b>N/A</b>	Flare Traversable LT?	N/A
			<b>N/A</b>	Landing Length (in)	N/A
			<b>N/A</b>	Landing Width (in)	N/A
			<b>N/A</b>	Landing Slope (%)	N/A
			<b>N/A</b>	Landing X Slope (%)	N/A
<p>Surveyor Notes:</p> <p><b>N/A</b></p> <p>PROW/ADA:</p> <p><b>Not Found, R304.2.2, R304.5.3</b></p>			<b>N/A</b>	Flare Type RT	N/A
			<b>N/A</b>	Flare Slope RT (%)	N/A
			<b>N/A</b>	Flare Traversable RT?	N/A
			<b>N/A</b>	DWS Provided?	N/A
			<b>N/A</b>	DWS Contrast?	N/A
			<b>N/A</b>	DWS Length (in)	N/A
			<b>N/A</b>	DWS Full Width?	N/A
			<b>N/A</b>	DWS Offset (in)	N/A
