Access Compliance Report

Public Rights-of-Way

(Curb Ramps)

Intersection ID: 17342	Main Street: AUTUMN_RAIN_LN	Cross Street: KIRKFIELD_CT	Location: NW
ADA ID: CEE5C2F417B3	Ramp Type: PerpDiag	Initial Pass/Fail: Fail	Overall Compliance: No
Severity Score: 37.5			
Codes/Mitigation Info/Possible Solution		Field Measurements/Component Compliance

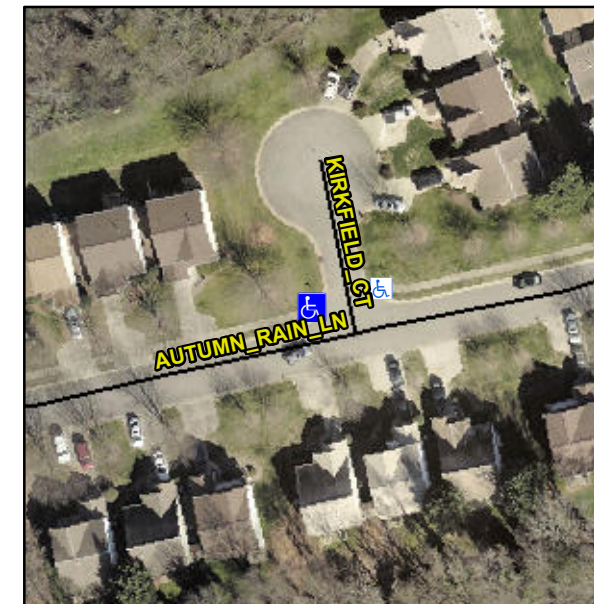
Not Found, R304.2.2, R304.5.3

Compliance	Description	Data	Compliance	Description	Data
N/A	Ramp Length (in)	51.0	No	Ramp Slope (%)	10.6
Yes	Ramp Width (in)	72.0	No	Ramp XSlope (%)	7.5
N/A	Flare Type LT	N/A	N/A	Flare Type RT	N/A
N/A	Flare Slope LT (%)	N/A	N/A	Flare Slope RT (%)	N/A
N/A	Flare Traversable LT?	N/A	N/A	Flare Traversable RT?	N/A
N/A	Landing Length (in)	N/A	N/A	DWS Provided?	N/A
N/A	Landing Width (in)	N/A	N/A	DWS Contrast?	N/A
N/A	Landing Slope (%)	N/A	N/A	DWS Length (in)	N/A
N/A	Landing X Slope (%)	N/A	N/A	DWS Full Width?	N/A
N/A	Landing Curb? (Y/N)	N/A	N/A	DWS Offset (in)	N/A
N/A	Shared Landing?	N/A			
N/A	Gutter Ponding?	N/A	N/A	Gutter Slope (%)	N/A
N/A	Gutter Lip Ht (in)	N/A	N/A	Gutter X Slope (%)	N/A
N/A	Painted X Walk1?	No	N/A	Painted X Walk2?	No
	X Walk 1 Direction	To S		X Walk 2 Direction	To E
N/A	X Walk 1 Width (in)	N/A	N/A	X Walk 2 Width (in)	N/A
	X Walk 1 Slope (%)	3.4		X Walk 2 Slope (%)	4.5
	X Walk 1 X Slope (%)	4.8		X Walk 2 X Slope (%)	1.8

N/A	Ramp inside XWalk1?	N/A	N/A	Ramp inside XWalk2?	N/A
	Road Slope (%)	4.7	N/A	Clear Space?	N/A
	Road X Slope (%)	2.1	N/A	Clear Space to XWalk (in)	N/A
N/A	Any Obstructions?	N/A	N/A	Storm Grate/Utility Hazard?	N/A
	Obstruction Type			Storm Grate/Utility Type	
		N/A			N/A
		Yes		Surface Condition? (G/P)	Good

Remove & Replace Curb Ramp With Two New Directional Ramps or Equivalent.
