Access Compliance Report

Public Rights-of-Way

(Curb Ramps)

Intersection ID: 3757	Main Street: DAVIS_LAKE_PY	Cross Street: POPLAR_GROVE_DR	Location: NE
ADA ID: CEEC3787E079	Ramp Type: Perp	Initial Pass/Fail: Pass	Overall Compliance: No
Severity Score: 27.5			
Codes/Mitigation Info/Possible Solution		Field Measurements/Component Compliance

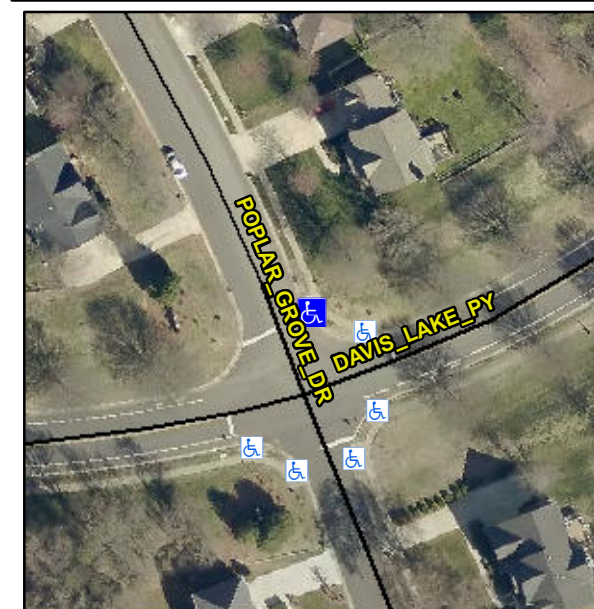
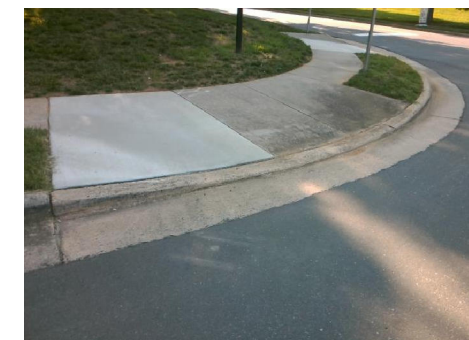
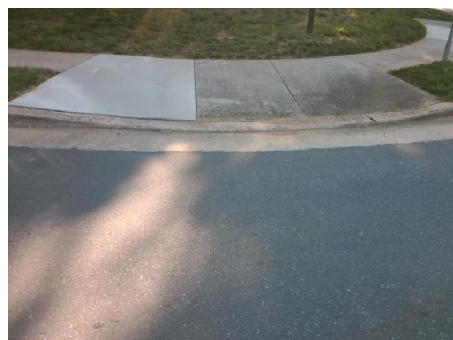
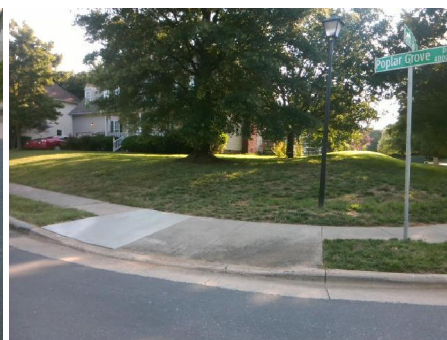
Compliance	Description	Data	Compliance	Description	Data
N/A	Ramp Length (in)	93.0	No	Ramp Slope (%)	9.4
Yes	Ramp Width (in)	48.0	Yes	Ramp XSlope (%)	0.6
N/A	Flare Type LT	Sloped	N/A	Flare Type RT	N/A
N/A	Flare Slope LT (%)	8.2	Yes	Flare Slope RT (%)	2.9
N/A	Flare Traversable LT?	Yes	N/A	Flare Traversable RT?	Yes
No	Landing Length (in)	N/A	No	DWS Provided?	No
No	Landing Width (in)	N/A	N/A	DWS Contrast?	No
No	Landing Slope (%)	N/A	N/A	DWS Length (in)	N/A
No	Landing X Slope (%)	N/A	N/A	DWS Full Width?	No
N/A	Landing Curb? (Y/N)	No	N/A	DWS Offset (in)	N/A
N/A	Shared Landing?	No			
Yes	Gutter Ponding?	No	No	Gutter Slope (%)	6.8
Yes	Gutter Lip Ht (in)	0.0	Yes	Gutter X Slope (%)	0.1
N/A	Painted X Walk1?	No	N/A	Painted X Walk2?	N/A
	X Walk 1 Direction	To W		X Walk 2 Direction	N/A
N/A	X Walk 1 Width (in)	N/A	N/A	X Walk 2 Width (in)	N/A
	X Walk 1 Slope (%)	1.3		X Walk 2 Slope (%)	N/A
	X Walk 1 X Slope (%)	1.8		X Walk 2 X Slope (%)	N/A

N/A	Ramp inside XWalk1?	N/A	N/A	Ramp inside XWalk2?	N/A
	Road Slope (%)	N/A	N/A	Clear Space?	Yes
	Road X Slope (%)	N/A	N/A	Clear Space to XWalk (in)	N/A
Yes	Any Obstructions?	No	Yes	Storm Grate/Utility Hazard?	No
	Obstruction Type			Storm Grate/Utility Type	
		N/A			N/A
			Yes	Surface Condition? (G/P)	Good

Possible Solutions:

**Remove & Replace Entire Ramp.
Remove & Replace Gutter.**
