# Access Compliance Report

## Public Rights-of-Way

### (Curb Ramps)

Intersection ID: 4979	Main Street: BETTERTON_LN	Cross Street: CRISFIELD_RD	Location: SE
ADA ID: CEEE06A9AF7A	Ramp Type: Perp	Initial Pass/Fail: Fail	Overall Compliance: No
Severity Score: 26.25			
Codes/Mitigation Info/Possible Solution		Field Measurements/Component Compliance

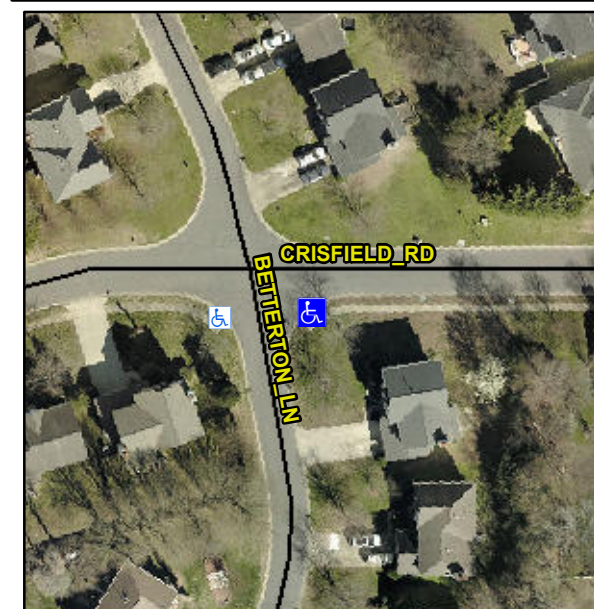
Compliance	Description	Data	Compliance	Description	Data
N/A	Ramp Length (in)	47.0	No	Ramp Slope (%)	17.8
Yes	Ramp Width (in)	48.0	No	Ramp XSlope (%)	2.3
N/A	Flare Type LT	N/A	N/A	Flare Type RT	N/A
N/A	Flare Slope LT (%)	N/A	N/A	Flare Slope RT (%)	N/A
N/A	Flare Traversable LT?	N/A	N/A	Flare Traversable RT?	N/A
N/A	Landing Length (in)	N/A	N/A	DWS Provided?	N/A
N/A	Landing Width (in)	N/A	N/A	DWS Contrast?	N/A
N/A	Landing Slope (%)	N/A	N/A	DWS Length (in)	N/A
N/A	Landing X Slope (%)	N/A	N/A	DWS Full Width?	N/A
N/A	Landing Curb? (Y/N)	N/A	N/A	DWS Offset (in)	N/A
N/A	Shared Landing?	N/A			
N/A	Gutter Ponding?	N/A	N/A	Gutter Slope (%)	N/A
N/A	Gutter Lip Ht (in)	N/A	N/A	Gutter X Slope (%)	N/A
N/A	Painted X Walk1?	No	N/A	Painted X Walk2?	N/A
	X Walk 1 Direction	To W		X Walk 2 Direction	N/A
N/A	X Walk 1 Width (in)	N/A	N/A	X Walk 2 Width (in)	N/A
	X Walk 1 Slope (%)	3.6		X Walk 2 Slope (%)	N/A
	X Walk 1 X Slope (%)	5.1		X Walk 2 X Slope (%)	N/A

N/A	Ramp inside XWalk1?	N/A	N/A	Ramp inside XWalk2?	N/A
	Road Slope (%)	N/A	N/A	Clear Space?	N/A
	Road X Slope (%)	N/A	N/A	Clear Space to XWalk (in)	N/A
N/A	Any Obstructions?	N/A	N/A	Storm Grate/Utility Hazard?	N/A
	Obstruction Type			Storm Grate/Utility Type	
		N/A			N/A
			Yes	Surface Condition? (G/P)	Good

**Remove & Replace Entire Ramp.**

**R304.2.2, R304.5.3**
