Access Compliance Report

Public Rights-of-Way

(Curb Ramps)

Intersection ID: N/A	Main Street: CRISFIELD_RD	Cross Street: MARBURY_RD	Location: SW
ADA ID: CEFAE2D0E11E	Ramp Type: PerpDiag	Initial Pass/Fail: Fail	Overall Compliance: No
Severity Score: 13.75			
Codes/Mitigation Info/Possible Solution		Field Measurements/Component Compliance

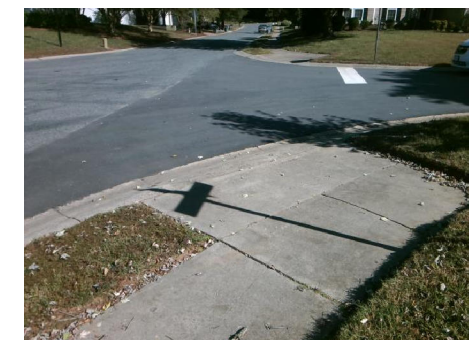
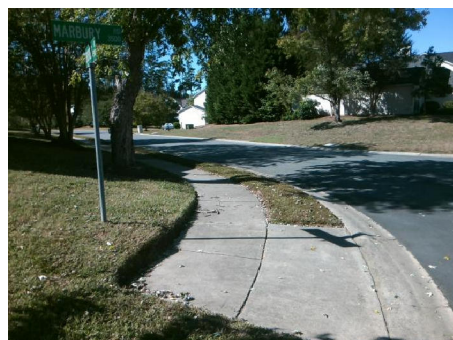
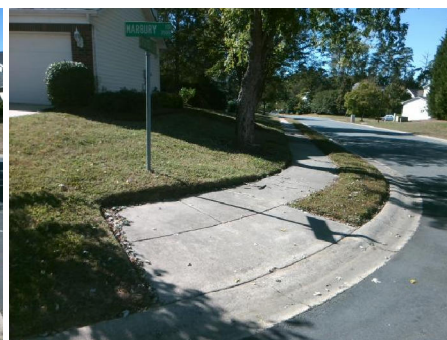
Compliance	Description	Data	Compliance	Description	Data
N/A	Ramp Length (in)	95.0	No	Ramp Slope (%)	9.9
Yes	Ramp Width (in)	60.0	No	Ramp XSlope (%)	4.6
N/A	Flare Type LT	N/A	N/A	Flare Type RT	N/A
N/A	Flare Slope LT (%)	N/A	N/A	Flare Slope RT (%)	N/A
N/A	Flare Traversable LT?	N/A	N/A	Flare Traversable RT?	N/A
N/A	Landing Length (in)	N/A	N/A	DWS Provided?	N/A
N/A	Landing Width (in)	N/A	N/A	DWS Contrast?	N/A
N/A	Landing Slope (%)	N/A	N/A	DWS Length (in)	N/A
N/A	Landing X Slope (%)	N/A	N/A	DWS Full Width?	N/A
N/A	Landing Curb? (Y/N)	N/A	N/A	DWS Offset (in)	N/A
N/A	Shared Landing?	N/A			
N/A	Gutter Ponding?	N/A	N/A	Gutter Slope (%)	N/A
N/A	Gutter Lip Ht (in)	N/A	N/A	Gutter X Slope (%)	N/A
N/A	Painted X Walk1?	No	N/A	Painted X Walk2?	No
	X Walk 1 Direction	To E		X Walk 2 Direction	To N
N/A	X Walk 1 Width (in)	N/A	N/A	X Walk 2 Width (in)	N/A
	X Walk 1 Slope (%)	0.6		X Walk 2 Slope (%)	1.0
	X Walk 1 X Slope (%)	2.2		X Walk 2 X Slope (%)	0.2

N/A	Ramp inside XWalk1?	N/A	N/A	Ramp inside XWalk2?	N/A
	Road Slope (%)	1.8	N/A	Clear Space?	N/A
	Road X Slope (%)	1.1	N/A	Clear Space to XWalk (in)	N/A
N/A	Any Obstructions?	N/A	N/A	Storm Grate/Utility Hazard?	N/A
	Obstruction Type			Storm Grate/Utility Type	
		N/A			N/A
			Yes	Surface Condition? (G/P)	Good

Remove & Replace Curb Ramp With Two New Directional Ramps or Equivalent.
