11.2

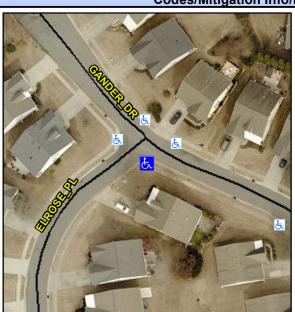
Total Cost: 3200.00

Compliance Description		Data	Compliance Description		Data
N/A	Ramp Length (in)	95.0	Yes	BlendTrans Slope (%)	4.0
No	Ramp Width (in)	41.0	No	BlendTrans XSlope (%)	5.1
N/A	Flare Type LT	N/A	N/A	Flare Type RT	N/A
N/A	Flare Slope LT (%)	N/A	N/A	Flare Slope RT (%)	N/A
N/A	Flare Traversable LT?	N/A	N/A	Flare Traversable RT?	N/A
N/A	Landing Length (in)	N/A	N/A	DWS Provided?	N/A
N/A	Landing Width (in)	N/A	N/A	DWS Contrast?	N/A
N/A	Landing Slope (%)	N/A	N/A	DWS Length (in)	N/A
N/A	Landing X Slope (%)	N/A	N/A	DWS Full Width?	N/A
N/A	Landing Curb? (Y/N)	N/A	N/A	DWS Offset (in)	N/A
N/A	Shared Landing?	N/A			
N/A	Gutter Ponding?	N/A	N/A	Gutter Slope (%)	N/A
N/A	Gutter Lip Ht (in)	N/A	N/A	Gutter X Slope (%)	N/A
N/A	Painted X Walk1?	No	N/A	Painted X Walk2?	No
	X Walk 1 Direction	To NE		X Walk 2 Direction	To NW
	X Walk 1 Width (in)	N/A		X Walk 2 Width (in)	N/A
	X Walk 1 Slope (%)	3.8		X Walk 2 Slope (%)	4.6
	X Walk 1 X Slope (%)	4.8		X Walk 2 X Slope (%)	0.7

Street 1 Name Stop Condition-Street 1 Street 2 Name Stop Condition-Street 2 **GANDER DR** None **ELROSE PL** StopSign
