Intersection ID: 30412	Main Street: COVENTRY_ROW_CT	Cross Street: SARDIS_RD	Location:	S
ADA ID: CF13933DD3B6	Ramp Type: ParaDiag	Initial Pass/Fail: Fail	Overall Compliance: No	Severity Score: 47.5

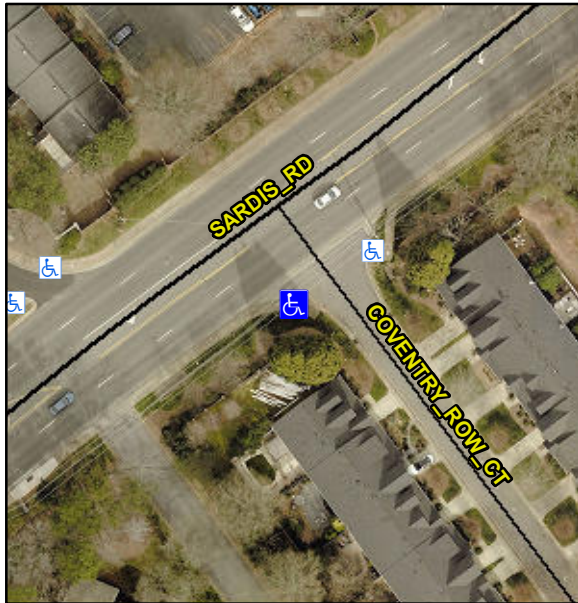
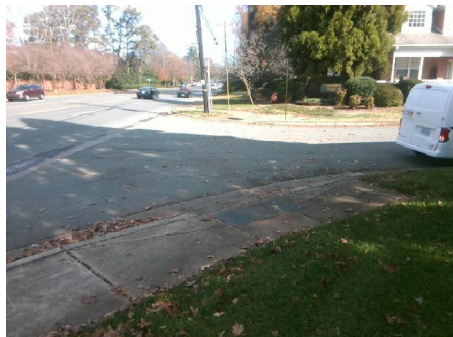
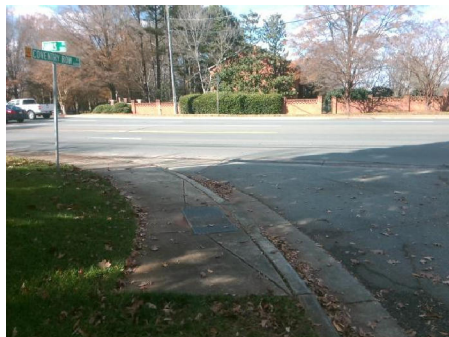
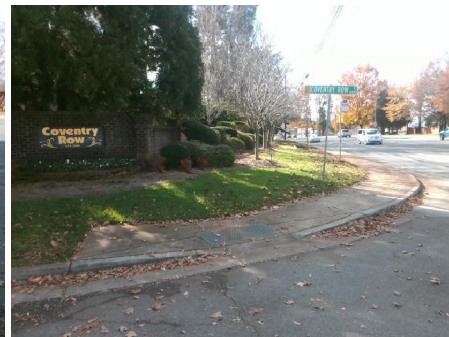
**R304.5.1, R304.5.3**

Compliance	Description	Data	Compliance	Description	Data
N/A	Ramp Length LT (in)	66.0	N/A	Ramp Length RT (in)	71.0
No	Ramp Width LT (in)	29.5	No	Ramp Width RT (in)	29.5
Yes	Ramp Slope LT (%)	6.3	Yes	Ramp Slope RT (%)	5.9
No	Ramp XSlope LT (%)	5.1	No	Ramp XSlope RT (%)	3.6
N/A	Landing Length (in)	N/A	N/A	DWS Provided?	N/A
N/A	Landing Width (in)	N/A	N/A	DWS Contrast?	N/A
N/A	Landing Slope (%)	N/A	N/A	DWS Length (in)	N/A
N/A	Landing X Slope (%)	N/A	N/A	DWS Full Width?	N/A
N/A	Landing Curb? (Y/N)	N/A	N/A	DWS Offset (in)	N/A
N/A	Shared Landing?	N/A			
N/A	Gutter Ponding?	N/A	N/A	Gutter Slope (%)	N/A
N/A	Gutter Lip Ht (in)	N/A	N/A	Gutter X Slope (%)	N/A
N/A	Painted X Walk1?	No	N/A	Painted X Walk2?	No
	X Walk 1 Direction	To NE		X Walk 2 Direction	To NW
N/A	X Walk 1 Width (in)	N/A	N/A	X Walk 2 Width (in)	N/A
	X Walk 1 Slope (%)	0.1		X Walk 2 Slope (%)	1.1
	X Walk 1 X Slope (%)	0.5		X Walk 2 X Slope (%)	0.5
N/A	Ramp inside XWalk1?	N/A	N/A	Ramp inside XWalk2?	N/A

Road Slope (%)	1.3	N/A	Clear Space?	N/A
	Road X Slope (%)	0.8	N/A	Clear Space to XWalk (in)	N/A
N/A	Any Obstructions?	N/A	N/A	Storm Grate/Utility Hazard?	N/A
	Obstruction Type			Storm Grate/Utility Type	
		N/A			N/A
			Yes	Surface Condition? (G/P)	Good
			N/A	Curb Slope (%)	9.3

**Remove & Replace Curb Ramp With Two New Directional Ramps or Equivalent.**
