# Access Compliance Report

## Public Rights-of-Way

### (Curb Ramps)

Intersection ID: 14086	Main Street: BALDWIN_AV	Cross Street: E_3RD_ST	Location:	N
ADA ID: CF172827FBA8	Ramp Type: Perp	Initial Pass/Fail: Fail	Overall Compliance: No	Severity Score: 22.5
Codes/Mitigation Info/Possible Solution		Field Measurements/Component Compliance

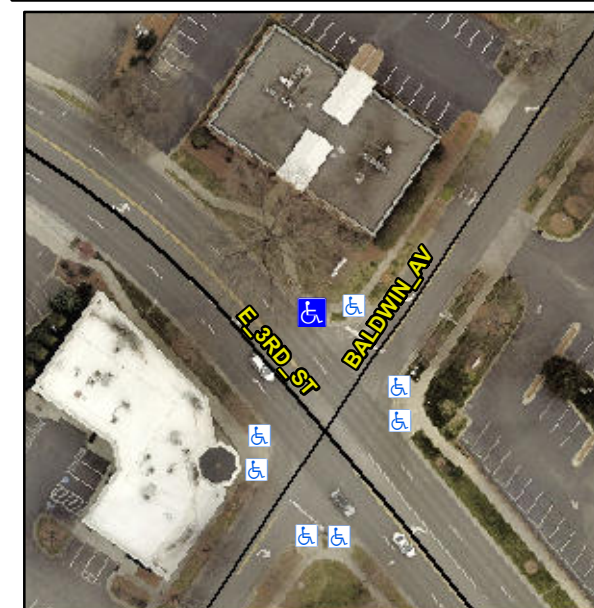
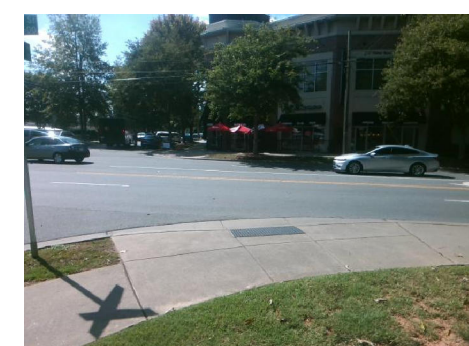
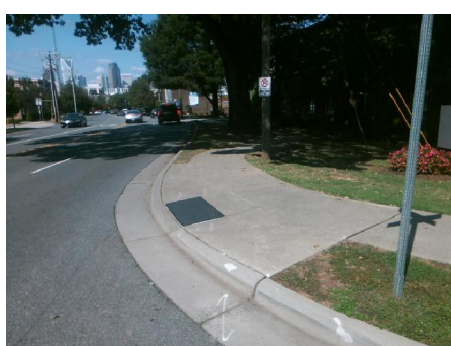
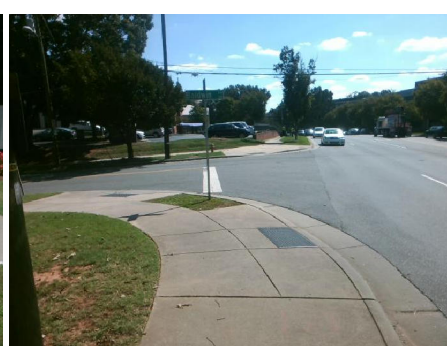
**Not Found, R304.5.1, R304.2.2, R304.5.3**

Compliance	Description	Data	Compliance	Description	Data
N/A	Ramp Length (in)	46.5	No	Ramp Slope (%)	9.4
No	Ramp Width (in)	42.5	No	Ramp XSlope (%)	2.1
N/A	Flare Type LT	N/A	N/A	Flare Type RT	N/A
N/A	Flare Slope LT (%)	N/A	N/A	Flare Slope RT (%)	N/A
N/A	Flare Traversable LT?	N/A	N/A	Flare Traversable RT?	N/A
N/A	Landing Length (in)	N/A	N/A	DWS Provided?	N/A
N/A	Landing Width (in)	N/A	N/A	DWS Contrast?	N/A
N/A	Landing Slope (%)	N/A	N/A	DWS Length (in)	N/A
N/A	Landing X Slope (%)	N/A	N/A	DWS Full Width?	N/A
N/A	Landing Curb? (Y/N)	N/A	N/A	DWS Offset (in)	N/A
N/A	Shared Landing?	N/A			
N/A	Gutter Ponding?	N/A	N/A	Gutter Slope (%)	N/A
N/A	Gutter Lip Ht (in)	N/A	N/A	Gutter X Slope (%)	N/A
N/A	Painted X Walk1?	No	N/A	Painted X Walk2?	N/A
	X Walk 1 Direction	To SW		X Walk 2 Direction	N/A
N/A	X Walk 1 Width (in)	N/A	N/A	X Walk 2 Width (in)	N/A
	X Walk 1 Slope (%)	1.8		X Walk 2 Slope (%)	N/A
	X Walk 1 X Slope (%)	1.3		X Walk 2 X Slope (%)	N/A

N/A	Ramp inside XWalk1?	N/A	N/A	Ramp inside XWalk2?	N/A
	Road Slope (%)	N/A	N/A	Clear Space?	N/A
	Road X Slope (%)	N/A	N/A	Clear Space to XWalk (in)	N/A
N/A	Any Obstructions?	N/A	N/A	Storm Grate/Utility Hazard?	N/A
	Obstruction Type			Storm Grate/Utility Type	
		N/A			N/A
			Yes	Surface Condition? (G/P)	Good

**Remove & Replace Entire Ramp.**

Total Cost: \$ 1850.00
