Access Compliance Report

Public Rights-of-Way

(Curb Ramps)

| Intersection ID: 10036710 | Main Street: S_CLARKSON_ST | Cross Street: N/A | Location: N |

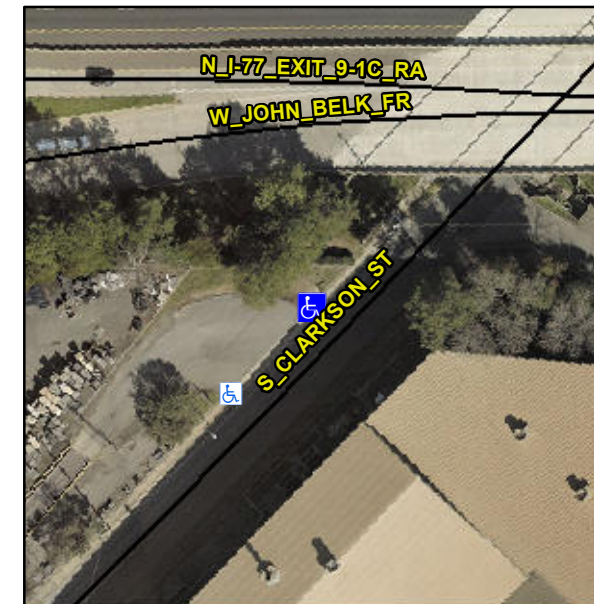
| ADA ID: CF1BFFF2DFF1 | Ramp Type: Perp | Initial Pass/Fail: Fail | Overall Compliance: No |

Not Found, R304.2.2, R304.5.3

| Compliance | Description | Data | Compliance | Description | Data |
|---|---|---|---|---|---|
| N/A | Ramp Length (in) | 55.0 | No | Ramp Slope (%) | 10.2 |
| Yes | Ramp Width (in) | 48.0 | No | Ramp XSlope (%) | 6.0 |

Remove & Replace Entire Ramp.
