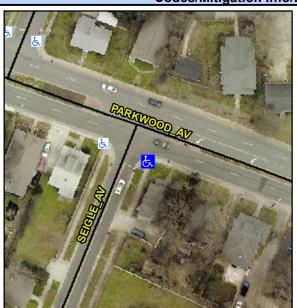
1850.00

Field Measurements/Component Compliance						
Compl	liance Description	Data	Comp	liance	Description	Data
N/A	Ramp Length (in)	80.0	Yes	Ramp	Slope (%)	6.2
No	Ramp Width (in)	47.5	No	Ramp	XSlope (%)	4.2
N/A	Flare Type LT	N/A	N/A	Flare	Type RT	N/A
N/A	Flare Slope LT (%)	N/A	N/A	Flare	Slope RT (%)	N/A
N/A	Flare Traversable LT?	N/A	N/A	Flare	Traversable RT?	N/A
N/A	Landing Length (in)	N/A	N/A	DWS	Provided?	N/A
N/A	Landing Width (in)	N/A	N/A	DWS	Contrast?	N/A
N/A	Landing Slope (%)	N/A	N/A	DWS	Length (in)	N/A
N/A	Landing X Slope (%)	N/A	N/A	DWS	Full Width?	N/A
N/A	Landing Curb? (Y/N)	N/A	N/A	DWS	Offset (in)	N/A
N/A	Shared Landing?	N/A				
N/A	Gutter Ponding?	N/A	N/A	Gutte	r Slope (%)	N/A
N/A	Gutter Lip Ht (in)	N/A	N/A	Gutte	r X Slope (%)	N/A
N/A	Painted X Walk1?	No	N/A	Painte	ed X Walk2?	N/A
	X Walk 1 Direction	To NW		X Wa	k 2 Direction	N/A
N/A	X Walk 1 Width (in)	N/A	N/A	X Wa	k 2 Width (in)	N/A
	X Walk 1 Slope (%)	6.8		X Wa	k 2 Slope (%)	N/A

THE RESERVE AND ADDRESS OF THE PARTY OF THE
Street 1 Name	SEIGLE AV
Stop Condition-Street 2	StopSign
Street 2 Name	N/A
Ston Condition-Street 1	N/A
