Access Compliance Report

Public Rights-of-Way

(Curb Ramps)

| Intersection ID: 7539 | Main Street: GEORGETOWN_DR | Cross Street: PONDELLA_DR | Location: E |

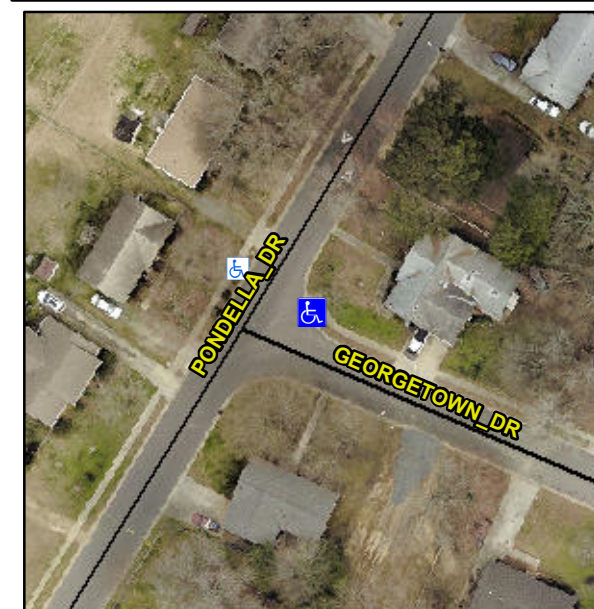
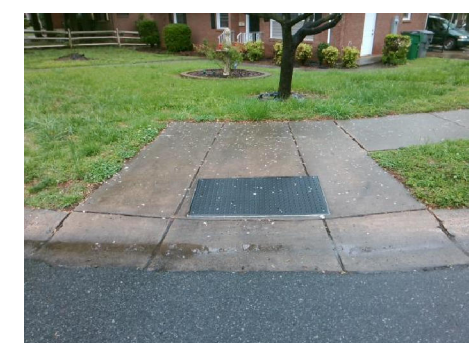
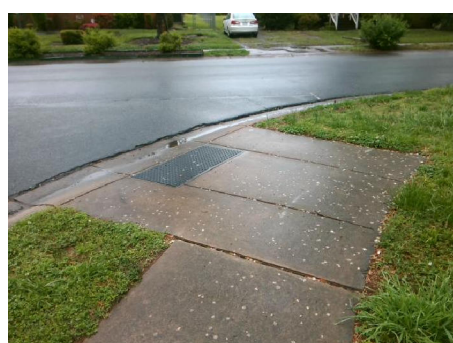
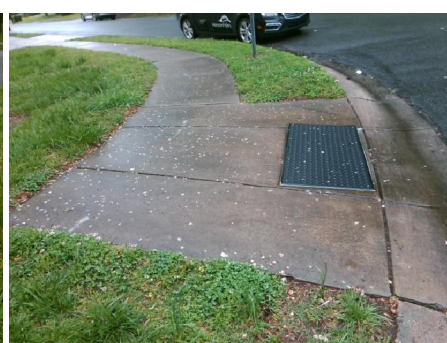
| ADA ID: CF243A6C543B | Ramp Type: Perp | Initial Pass/Fail: Fail | Overall Compliance: No |
| Severity Score: 8.75 | | | |

Not Found, R304.5.1

| Compliance | Description | Data | Compliance | Description | Data |
|---|---|---|---|---|---|
| No | Ramp Width (in) | 39.0 | Yes | Ramp XSlope (%) | 1.5 |

Remove & Replace Entire Ramp.
