Access Compliance Report Public Rights-of-Way (Curb Ramps)

Intersection ID: 30253 Main Street: CENTENNIAL_DR Cross Street: OLD_IRONSIDE_DR Location: N

ADA ID: CF353CC3D6CF Ramp Type: PerpDiag Initial Pass/Fail: Fail Overall Compliance: No Severity Score: 12.5

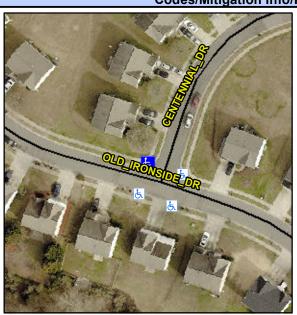
PROW/ADA:
Not Found, R304.5.3

Fleid Measurements/Component Compnance						
	Compliance Description		Data	Compliance Description		Data
	N/A	Ramp Length (in)	48.0	Yes	Ramp Slope (%)	5.8
	Yes	Ramp Width (in)	54.0	No	Ramp XSlope (%)	5.6
	N/A	Flare Type LT	N/A	N/A	Flare Type RT	N/A
	N/A	Flare Slope LT (%)	N/A	N/A	Flare Slope RT (%)	N/A
	N/A	Flare Traversable LT?	N/A	N/A	Flare Traversable RT?	N/A
	N/A	Landing Length (in)	N/A	N/A	DWS Provided?	N/A
	N/A	Landing Width (in)	N/A	N/A	DWS Contrast?	N/A
	N/A	Landing Slope (%)	N/A	N/A	DWS Length (in)	N/A
	N/A	Landing X Slope (%)	N/A	N/A	DWS Full Width?	N/A
	N/A	Landing Curb? (Y/N)	N/A	N/A	DWS Offset (in)	N/A
	N/A	Shared Landing?	N/A			
	N/A	Gutter Ponding?	N/A	N/A	Gutter Slope (%)	N/A
	N/A	Gutter Lip Ht (in)	0.5	N/A	Gutter X Slope (%)	N/A
	N/A	Painted X Walk1?	No	N/A	Painted X Walk2?	No
		X Walk 1 Direction	To S		X Walk 2 Direction	To SE
	N/A	X Walk 1 Width (in)	N/A	N/A	X Walk 2 Width (in)	N/A
		X Walk 1 Slope (%)	8.8		X Walk 2 Slope (%)	3.0

X Walk 1 X Slope (%)	2.0		X Walk 2 X Slope (%)	6.1
	N/A	Ramp inside XWalk1?	N/A	N/A	Ramp inside XWalk2?	N/A
		Road Slope (%)	2.1	N/A	Clear Space?	N/A
		Road X Slope (%)	8.3	N/A	Clear Space to XWalk (in)	N/A

Remove & Replace Curb Ramp With
Two New Directional Ramps or
Equivalent.

Total Cost: \$ 3200.00
