Access Compliance Report Public Rights-of-Way (Curb Ramps)

Intersection ID: 14522 Main Street: CARONIA_ST Cross Street: REID_AV Location: SW

ADA ID: CF3ACCA088D5 Ramp Type: Combination2Diag Initial Pass/Fail: Fail Overall Compliance: No Severity Score: 0

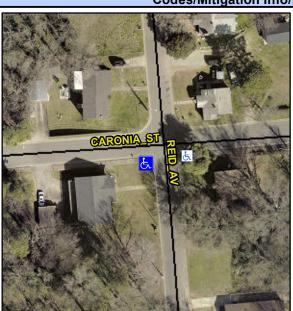
Not Found, R304.5.1, R304.5.3, R304.3.2

Comp	liance Description	Data		iance Description	
N/A	Ramp Length LT (in)	62.0	N/A	Ramp Length RT (in) N/A
Yes	Ramp Width LT (in)	61.0	N/A	Ramp Width RT (ii	n) N/A
No	Ramp Slope LT (%)	9.1	N/A	Ramp Slope RT (%	%) N/A
Yes	Ramp XSlope LT (%)	1.0	N/A	Ramp XSlope RT	(%) N/A
N/A	Ramp Length (in)	61.0	Yes	Ramp Slope (%)	4.6
No	Ramp Width (in)	33.0	No	Ramp XSlope (%)	7.0
N/A	Flare Type LT	N/A	N/A	Flare Type RT	N/A
N/A	Flare Slope LT (%)	N/A	N/A	Flare Slope RT (%) N/A
N/A	Flare Traversable LT?	N/A	N/A	Flare Traversable	RT? N/A
N/A	Landing Length (in)	N/A	N/A	DWS Provided?	N/A
N/A	Landing Width (in)	N/A	N/A	DWS Contrast?	N/A
N/A	Landing Slope (%)	N/A	N/A	DWS Length (in)	N/A
N/A	Landing X Slope (%)	N/A	N/A	DWS Full Width?	N/A
N/A	Landing Curb? (Y/N)	N/A	N/A	DWS Offset (in)	N/A
N/A	Shared Landing?	N/A			
N/A	Gutter Ponding?	N/A	N/A	Gutter Slope (%)	N/A
N/A	Gutter Lip Ht (in)	N/A	N/A	Gutter X Slope (%) N/A
N/A	Painted X Walk1?	No	N/A	Painted X Walk2?	No

X Walk 1 Direction	To E		X Walk 2 Direction	To N
	X Walk 1 Width (in)	N/A		X Walk 2 Width (in) N/A
	X Walk 1 Slope (%)	5.9		X Walk 2 Slope (%	0.8
	X Walk 1 X Slope (%)	0.4		X Walk 2 X Slope	(%) 4.6
N/A	Ramp inside XWalk1?	N/A	N/A	Ramp inside XWa	k2? N/A
	Road Slope (%)	3.6		Clear Space?	N/A
	Road X Slope (%)	4.8	N/A	Clear Space to XV	Valk (in) N/A
			N/A	Any Obstruction?	N/A
V				Obstruction Type	
					N/A

Remove & Replace Curb Ramp With Two New Directional Ramps or Equivalent.
