Access Compliance Report Public Rights-of-Way (Curb Ramps)

Intersection ID: 10036588Main Street: RUNNYMEDE_LNCross Street: N/ALocation:SWADA ID: CF3D3DC89157Ramp Type: PerpDiagInitial Pass/Fail: FailOverall Compliance: NoSeverity Score: 12.5

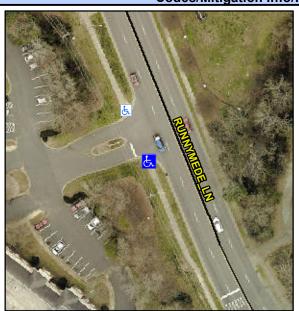
Not Found, R304.2.2

Compliance Description Data Compliance Description Data No Ramp Slope (%) N/A Ramp Length (in) 60.0 8.9 Yes Ramp XSlope (%) Yes Ramp Width (in) 48.0 0.3 N/A N/A Flare Type LT N/A Flare Type RT N/A N/A N/A N/A Flare Slope RT (%) N/A Flare Slope LT (%) N/A Flare Traversable LT? N/A N/A Flare Traversable RT? N/A N/A N/A N/A DWS Provided? N/A Landing Length (in) N/A Landing Width (in) N/A N/A **DWS Contrast?** N/A N/A N/A N/A Landing Slope (%) DWS Length (in) N/A N/A Landing X Slope (%) N/A N/A DWS Full Width? N/A N/A Landing Curb? (Y/N) N/A N/A DWS Offset (in) N/A N/A N/A Shared Landing? N/A **Gutter Ponding?** N/A N/A Gutter Slope (%) N/A N/A Gutter Lip Ht (in) N/A N/A Gutter X Slope (%) N/A N/A Painted X Walk1? No N/A Painted X Walk2? No X Walk 1 Direction To NE X Walk 2 Direction To N N/A N/A X Walk 1 Width (in) X Walk 2 Width (in) N/A X Walk 1 Slope (%) 2.5 X Walk 2 Slope (%) 0.8 X Walk 2 X Slope (%) X Walk 1 X Slope (%) 1.8 3.4 N/A N/A N/A Ramp inside XWalk2? N/A Ramp inside XWalk1? Road Slope (%) 3.0 N/A Clear Space? N/A N/A Road X Slope (%) 0.4 Clear Space to XWalk (in) N/A N/A N/A N/A Any Obstructions? Storm Grate/Utility Hazard? N/A **Obstruction Type** Storm Grate/Utility Type

Remove & Replace Curb Ramp With Two New Directional Ramps or Equivalent.
