Access Compliance Report

Public Rights-of-Way

(Curb Ramps)

| Intersection ID: 53281 | Main Street: BENFIELD_RD | Cross Street: I-485_RA | Location: SW |

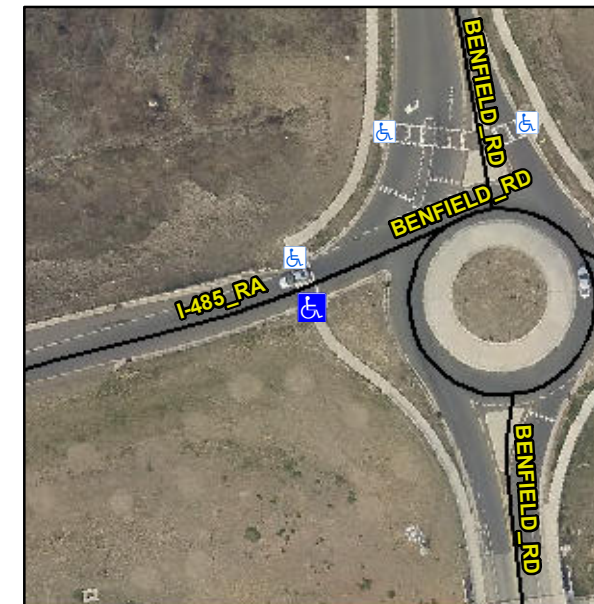
Remove & Replace Landing. Gutter Ponding Observed.

| Compliance | Description | Data | Compliance | Description | Data |
|---|---|---|---|---|---|
| No | Landing Slope (%) | 4.4 | Yes | DWS Length (in) | 24.0 |
| No | Gutter Ponding? | Yes | Yes | Gutter Slope (%) | 1.3 |

Possible Solutions:

Total Cost: \$ 1000.00
