Access Compliance Report

Public Rights-of-Way

(Curb Ramps)

Intersection ID: 27495	Main Street: BALLANTYNE COMMONS PY	Cross Street: NORTH COMMUNITY HOUSE RD	Location: NE
ADA ID: CF4F284BC510	Ramp Type: Perp	Initial Pass/Fail: Fail	Overall Compliance: No
Severity Score: 21.25			
Codes/Mitigation Info/Possible Solution		Field Measurements/Component Compliance

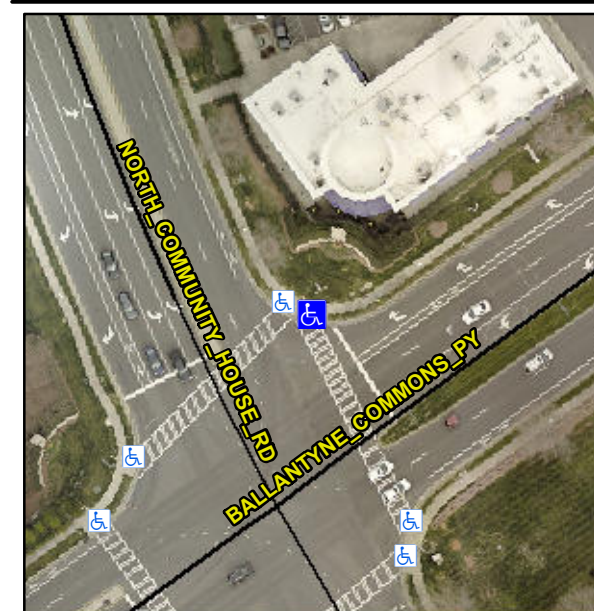
Not Found, R304.5.1, R304.2.2

Compliance	Description	Data	Compliance	Description	Data
N/A	Ramp Length (in)	48.0	No	Ramp Slope (%)	8.4
No	Ramp Width (in)	47.0	Yes	Ramp XSlope (%)	1.3
N/A	Flare Type LT	N/A	N/A	Flare Type RT	N/A
N/A	Flare Slope LT (%)	N/A	N/A	Flare Slope RT (%)	N/A
N/A	Flare Traversable LT?	N/A	N/A	Flare Traversable RT?	N/A
N/A	Landing Length (in)	N/A	N/A	DWS Provided?	N/A
N/A	Landing Width (in)	N/A	N/A	DWS Contrast?	N/A
N/A	Landing Slope (%)	N/A	N/A	DWS Length (in)	N/A
N/A	Landing X Slope (%)	N/A	N/A	DWS Full Width?	N/A
N/A	Landing Curb? (Y/N)	N/A	N/A	DWS Offset (in)	N/A
N/A	Shared Landing?	N/A			
N/A	Gutter Ponding?	N/A	N/A	Gutter Slope (%)	N/A
N/A	Gutter Lip Ht (in)	N/A	N/A	Gutter X Slope (%)	N/A
N/A	Painted X Walk1?	Yes	N/A	Painted X Walk2?	N/A
	X Walk 1 Direction	To SE		X Walk 2 Direction	N/A
N/A	X Walk 1 Width (in)	131.5	N/A	X Walk 2 Width (in)	N/A
	X Walk 1 Slope (%)	2.8		X Walk 2 Slope (%)	N/A
	X Walk 1 X Slope (%)	4.3		X Walk 2 X Slope (%)	N/A

N/A	Ramp inside XWalk1?	Yes	N/A	Ramp inside XWalk2?	N/A
	Road Slope (%)	N/A	N/A	Clear Space?	N/A
	Road X Slope (%)	N/A	N/A	Clear Space to XWalk (in)	N/A
N/A	Any Obstructions?	N/A	N/A	Storm Grate/Utility Hazard?	N/A
	Obstruction Type			Storm Grate/Utility Type	
		N/A			N/A
		Yes		Surface Condition? (G/P)	Good

Possible Solutions:

Remove & Replace Entire Ramp.
