Access Compliance Report

Public Rights-of-Way

(Curb Ramps)

Intersection ID: 16513	Main Street: BILTMORE_DR	Cross Street: COLVILLE_RD	Location: SW
ADA ID: CF7260803404	Ramp Type: Perp	Initial Pass/Fail: Fail	Overall Compliance: No
Codes/Mitigation Info/Possible Solution		Field Measurements/Component Compliance	
Severity Score: 13.75

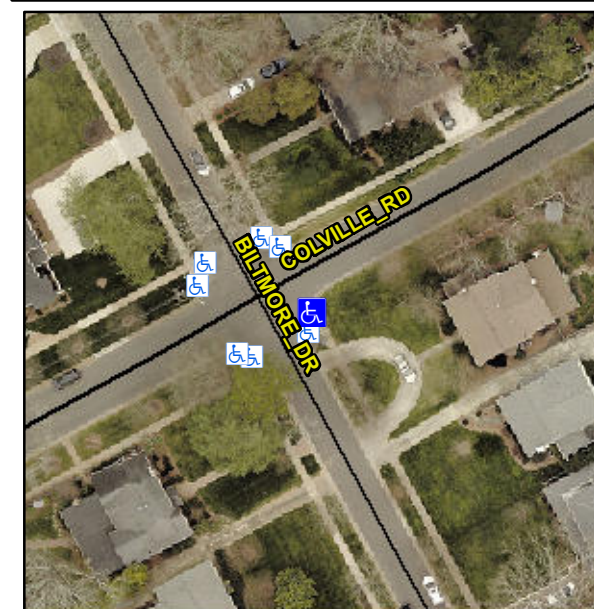
R304.2.2, R304.5.3

Compliance	Description	Data	Compliance	Description	Data
N/A	Ramp Length (in)	68.0	No	Ramp Slope (%)	8.7
Yes	Ramp Width (in)	70.0	No	Ramp XSlope (%)	3.9
N/A	Flare Type LT	N/A	N/A	Flare Type RT	N/A
N/A	Flare Slope LT (%)	N/A	N/A	Flare Slope RT (%)	N/A
N/A	Flare Traversable LT?	N/A	N/A	Flare Traversable RT?	N/A
N/A	Landing Length (in)	N/A	N/A	DWS Provided?	N/A
N/A	Landing Width (in)	N/A	N/A	DWS Contrast?	N/A
N/A	Landing Slope (%)	N/A	N/A	DWS Length (in)	N/A
N/A	Landing X Slope (%)	N/A	N/A	DWS Full Width?	N/A
N/A	Landing Curb? (Y/N)	N/A	N/A	DWS Offset (in)	N/A
N/A	Shared Landing?	N/A			
N/A	Gutter Ponding?	N/A	N/A	Gutter Slope (%)	N/A
N/A	Gutter Lip Ht (in)	N/A	N/A	Gutter X Slope (%)	N/A
N/A	Painted X Walk1?	No	N/A	Painted X Walk2?	N/A
	X Walk 1 Direction	To N		X Walk 2 Direction	N/A
N/A	X Walk 1 Width (in)	N/A	N/A	X Walk 2 Width (in)	N/A
	X Walk 1 Slope (%)	2.9		X Walk 2 Slope (%)	N/A
	X Walk 1 X Slope (%)	1.0		X Walk 2 X Slope (%)	N/A

N/A	Ramp inside XWalk1?	N/A	N/A	Ramp inside XWalk2?	N/A
	Road Slope (%)	N/A	N/A	Clear Space?	N/A
	Road X Slope (%)	N/A	N/A	Clear Space to XWalk (in)	N/A
N/A	Any Obstructions?	N/A	N/A	Storm Grate/Utility Hazard?	N/A
	Obstruction Type			Storm Grate/Utility Type	
		N/A			N/A
			Yes	Surface Condition? (G/P)	Good

Possible Solutions:

Remove & Replace Entire Ramp.
