Access Compliance Report Public Rights-of-Way (Curb Ramps)

Intersection ID: 30452 Main Street: CRESCENT_EXECUTIVE_DR Cross Street: GREEN_RIDGE_DR Location: SW

ADA ID: CF75CB221E36 Ramp Type: Combination2 Initial Pass/Fail: Fail Overall Compliance: No Severity Score: 13.75

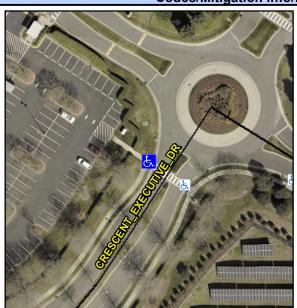
PROW/ADA:
Not Found, R304.2.2, R304.5.3

Compliance Description Data Compliance Description Data N/A Ramp Length RT (in) N/A Ramp Length LT (in) 59.0 N/A N/A Yes Ramp Width LT (in) 60.0 Ramp Width RT (in) N/A N/A Yes Ramp Slope LT (%) 7.5 Ramp Slope RT (%) N/A Ramp XSlope LT (%) N/A Ramp XSlope RT (%) Yes 1.0 N/A N/A Ramp Length (in) 48.0 Nο Ramp Slope (%) 8.5 96.0 No Ramp XSlope (%) 2.5 Yes Ramp Width (in) N/A Flare Type LT N/A N/A Flare Type RT N/A N/A N/A N/A Flare Slope LT (%) Flare Slope RT (%) N/A N/A Flare Traversable LT? N/A N/A Flare Traversable RT? N/A N/A Landing Length (in) N/A N/A DWS Provided? N/A N/A N/A **DWS Contrast?** N/A Landing Width (in) N/A N/A Landing Slope (%) N/A N/A DWS Length (in) N/A N/A Landing X Slope (%) N/A N/A DWS Full Width? N/A N/A Landing Curb? (Y/N) N/A N/A DWS Offset (in) N/A N/A Shared Landing? N/A N/A Gutter Ponding? N/A N/A Gutter Slope (%) N/A N/A N/A Gutter Lip Ht (in) N/A Gutter X Slope (%) N/A N/A N/A Painted X Walk1? Yes Painted X Walk2? N/A To SE N/A X Walk 1 Direction X Walk 2 Direction X Walk 1 Width (in) 76.0 X Walk 2 Width (in) N/A 3.8 N/A X Walk 1 Slope (%) X Walk 2 Slope (%) X Walk 1 X Slope (%) 1.6 X Walk 2 X Slope (%) N/A N/A Ramp inside XWalk1? No N/A Ramp inside XWalk2? N/A Road Slope (%) N/A Clear Space? N/A Road X Slope (%) N/A N/A Clear Space to XWalk (in) N/A N/A Any Obstruction? N/A **Obstruction Type**

Remove & Replace Entire Ramp.
Restripe Crosswalk.
