Access Compliance Report

Public Rights-of-Way

(Curb Ramps)

Intersection ID: 14530	Main Street: E_5TH_ST	Cross Street: N_LAUREL_AV	Location: NE
ADA ID: CF7DC3CC1C13	Ramp Type: BlendTrans2	Initial Pass/Fail: Fail	Overall Compliance: No
		Severity Score: 1.25

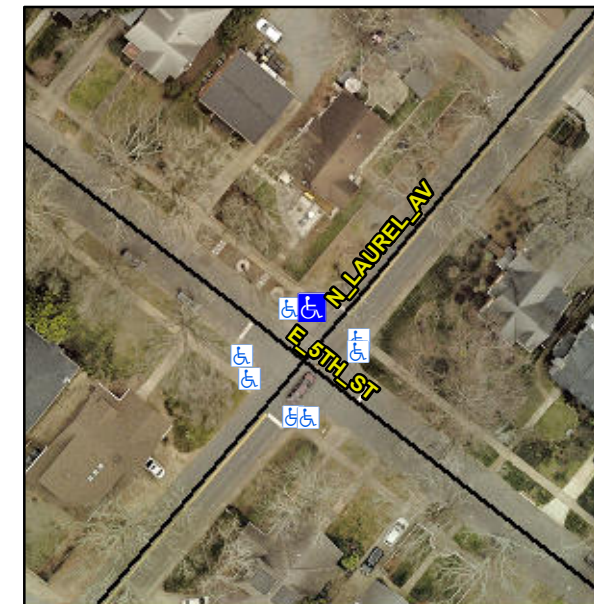
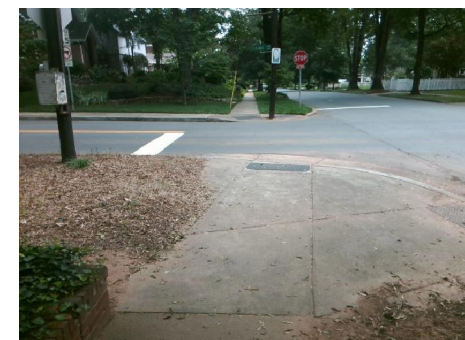
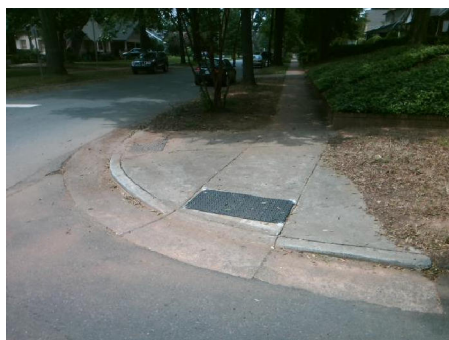
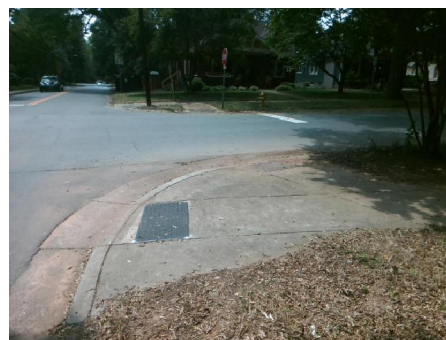
Compliance	Description	Data	Compliance	Description	Data
N/A	Ramp Length (in)	116.0	Yes	BlendTrans Slope (%)	4.8
Yes	Ramp Width (in)	48.0	No	BlendTrans XSlope (%)	2.3
N/A	Flare Type LT	N/A	N/A	Flare Type RT	N/A
N/A	Flare Slope LT (%)	N/A	N/A	Flare Slope RT (%)	N/A
N/A	Flare Traversable LT?	N/A	N/A	Flare Traversable RT?	N/A
N/A	Landing Length (in)	N/A	N/A	DWS Provided?	N/A
N/A	Landing Width (in)	N/A	N/A	DWS Contrast?	N/A
N/A	Landing Slope (%)	N/A	N/A	DWS Length (in)	N/A
N/A	Landing X Slope (%)	N/A	N/A	DWS Full Width?	N/A
N/A	Landing Curb? (Y/N)	N/A	N/A	DWS Offset (in)	N/A
N/A	Shared Landing?	N/A			
N/A	Gutter Ponding?	N/A	N/A	Gutter Slope (%)	N/A
N/A	Gutter Lip Ht (in)	N/A	N/A	Gutter X Slope (%)	N/A
N/A	Painted X Walk1?	No	N/A	Painted X Walk2?	N/A
	X Walk 1 Direction	To SE		X Walk 2 Direction	N/A
	X Walk 1 Width (in)	N/A		X Walk 2 Width (in)	N/A
	X Walk 1 Slope (%)	0.2		X Walk 2 Slope (%)	N/A
	X Walk 1 X Slope (%)	0.1		X Walk 2 X Slope (%)	N/A

N/A	Ramp inside XWalk1?	N/A	N/A	Ramp inside XWalk2?	N/A
	Road Slope (%)	0.1		Clear Space?	N/A
	Road X Slope (%)	0.2	N/A	Clear Space to XWalk (in)	N/A
N/A	Any Obstructions?	N/A	N/A	Storm Grate/Utility Hazard?	N/A
	Obstruction Type			Storm Grate/Utility Type	
		N/A			N/A
			Yes	Surface Condition? (G/P)	Good
			N/A	Curb Slope (%)	5.0

Remove & Replace Curb Ramp With Two New Directional Ramps or Equivalent.

Total Cost: \$ **3200.00**
