Access Compliance Report Public Rights-of-Way (Curb Ramps)

Intersection ID: 11388 Main Street: FOXFORD PL **Cross Street: STONEHAVEN DR** Location: SW **ADA ID: CF8BC884446A** Ramp Type: BlendTrans1 Initial Pass/Fail: Fail **Overall Compliance: No** 10 **Severity Score:**

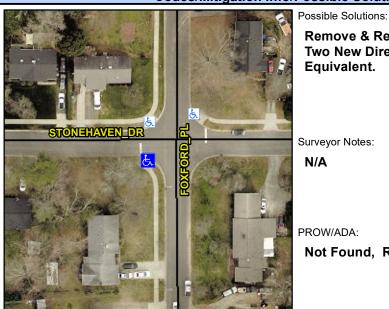
Not Found, R304.5.1, R304.5.3

With	N/A	Ramp Length (in)	72.0	Yes	BlendTrans Slope (%)
	No	Ramp Width (in)	47.5	No	BlendTrans XSlope (%)
	N/A	Flare Type LT	N/A	N/A	Flare Type RT
	N/A	Flare Slope LT (%)	N/A	N/A	Flare Slope RT (%)
	N/A	Flare Traversable LT?	N/A	N/A	Flare Traversable RT?
	N/A	Landing Length (in)	N/A	N/A	DWS Provided?
	N/A	Landing Width (in)	N/A	N/A	DWS Contrast?
	N/A	Landing Slope (%)	N/A	N/A	DWS Length (in)
	N/A	Landing X Slope (%)	N/A	N/A	DWS Full Width?
	N/A	Landing Curb? (Y/N)	N/A	N/A	DWS Offset (in)
	N/A	Shared Landing?	N/A		
	N/A	Gutter Ponding?	N/A	N/A	Gutter Slope (%)
	N/A	Gutter Lip Ht (in)	N/A	N/A	Gutter X Slope (%)
	N/A	Painted X Walk1?	No	N/A	Painted X Walk2?
		X Walk 1 Direction	To N		X Walk 2 Direction
		X Walk 1 Width (in)	N/A		X Walk 2 Width (in)
		X Walk 1 Slope (%)	2.3		X Walk 2 Slope (%)
		X Walk 1 X Slope (%)	2.5		X Walk 2 X Slope (%)
	N/A	Ramp inside XWalk1?	N/A	N/A	Ramp inside XWalk2?
		Road Slope (%)	2.5		Clear Space?

Road X Slope (%)	2.3	N/A	Clear Space to XWalk (in)
	N/A	Any Obstructions?	N/A	N/A	Storm Grate/Utility Hazard?
3200.00		Obstruction Type		l	Storm Grate/Utility Type
			N/A	l	
				Yes	Surface Condition? (G/P)

STONEHAVEN DR Street 1 Name Stop Condition-Street 1 StopSign Street 2 Name N/A Stop Condition-Street 2 N/A Remove & Replace Curb Ramp With Two New Directional Ramps or Equivalent.
