# Access Compliance Report

## Public Rights-of-Way

### (Curb Ramps)

Intersection ID: 14946	Main Street: DILWORTH RD WEST	Cross Street: E WORTHINGTON AV	Location: W
ADA ID: CF8BF3E9466D	Ramp Type: Perp	Initial Pass/Fail: Fail	Overall Compliance: No
Severity Score: 10			
Codes/Mitigation Info/Possible Solution		Field Measurements/Component Compliance

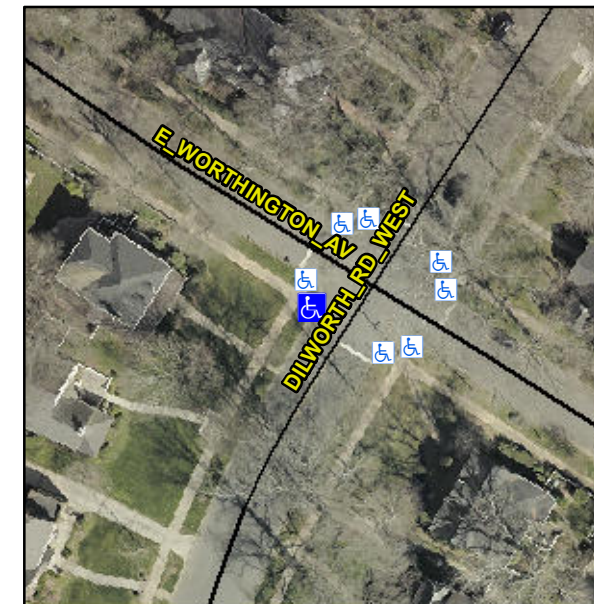
**R304.5.1, R304.5.3**

Compliance	Description	Data	Compliance	Description	Data
N/A	Ramp Length (in)	59.0	Yes	Ramp Slope (%)	6.5
No	Ramp Width (in)	40.0	No	Ramp XSlope (%)	4.5
N/A	Flare Type LT	N/A	N/A	Flare Type RT	N/A
N/A	Flare Slope LT (%)	N/A	N/A	Flare Slope RT (%)	N/A
N/A	Flare Traversable LT?	N/A	N/A	Flare Traversable RT?	N/A
N/A	Landing Length (in)	N/A	N/A	DWS Provided?	N/A
N/A	Landing Width (in)	N/A	N/A	DWS Contrast?	N/A
N/A	Landing Slope (%)	N/A	N/A	DWS Length (in)	N/A
N/A	Landing X Slope (%)	N/A	N/A	DWS Full Width?	N/A
N/A	Landing Curb? (Y/N)	N/A	N/A	DWS Offset (in)	N/A
N/A	Shared Landing?	N/A			
N/A	Gutter Ponding?	N/A	N/A	Gutter Slope (%)	N/A
N/A	Gutter Lip Ht (in)	N/A	N/A	Gutter X Slope (%)	N/A
N/A	Painted X Walk1?	No	N/A	Painted X Walk2?	N/A
	X Walk 1 Direction	To SE		X Walk 2 Direction	N/A
N/A	X Walk 1 Width (in)	N/A	N/A	X Walk 2 Width (in)	N/A
	X Walk 1 Slope (%)	3.9		X Walk 2 Slope (%)	N/A
	X Walk 1 X Slope (%)	0.7		X Walk 2 X Slope (%)	N/A

N/A	Ramp inside XWalk1?	N/A	N/A	Ramp inside XWalk2?	N/A
	Road Slope (%)	N/A	N/A	Clear Space?	N/A
	Road X Slope (%)	N/A	N/A	Clear Space to XWalk (in)	N/A
N/A	Any Obstructions?	N/A	N/A	Storm Grate/Utility Hazard?	N/A
	Obstruction Type			Storm Grate/Utility Type	
		N/A			N/A
		Yes		Surface Condition? (G/P)	Good

**Remove & Replace Entire Ramp.**

Total Cost: \$ 1850.00
